# From Malfunction to Solution

*Advanced Failure Analysis for  
Materials & Electronics*

Industrial Applications of  
Advanced Metrology  
Episode 44

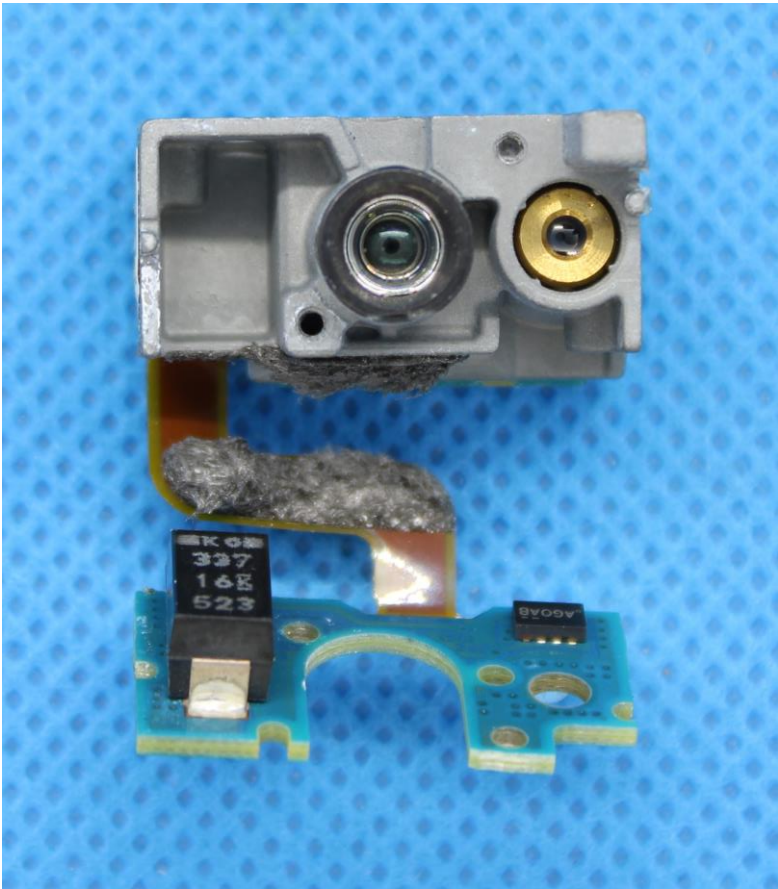
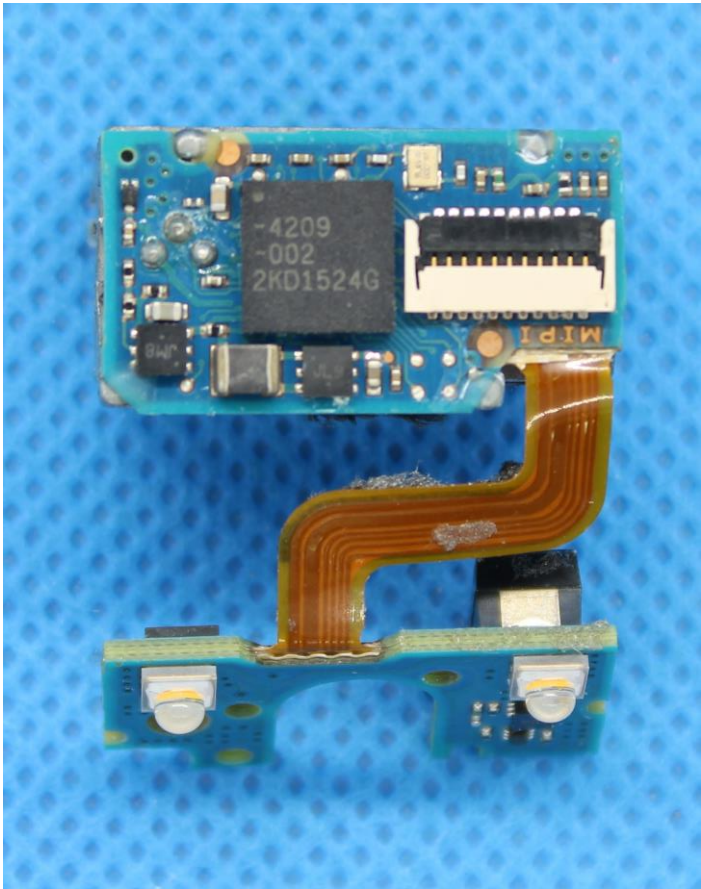
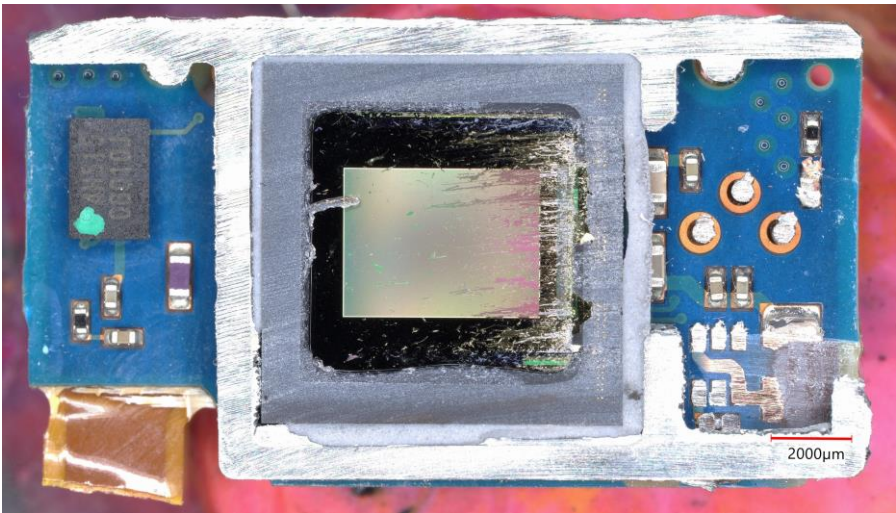
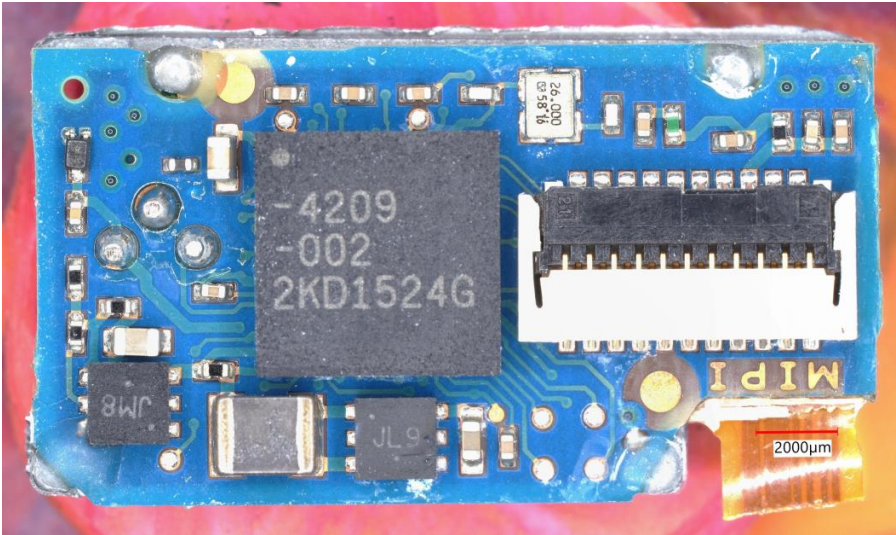
# Overall Inspection: No Defect/Damages Visible

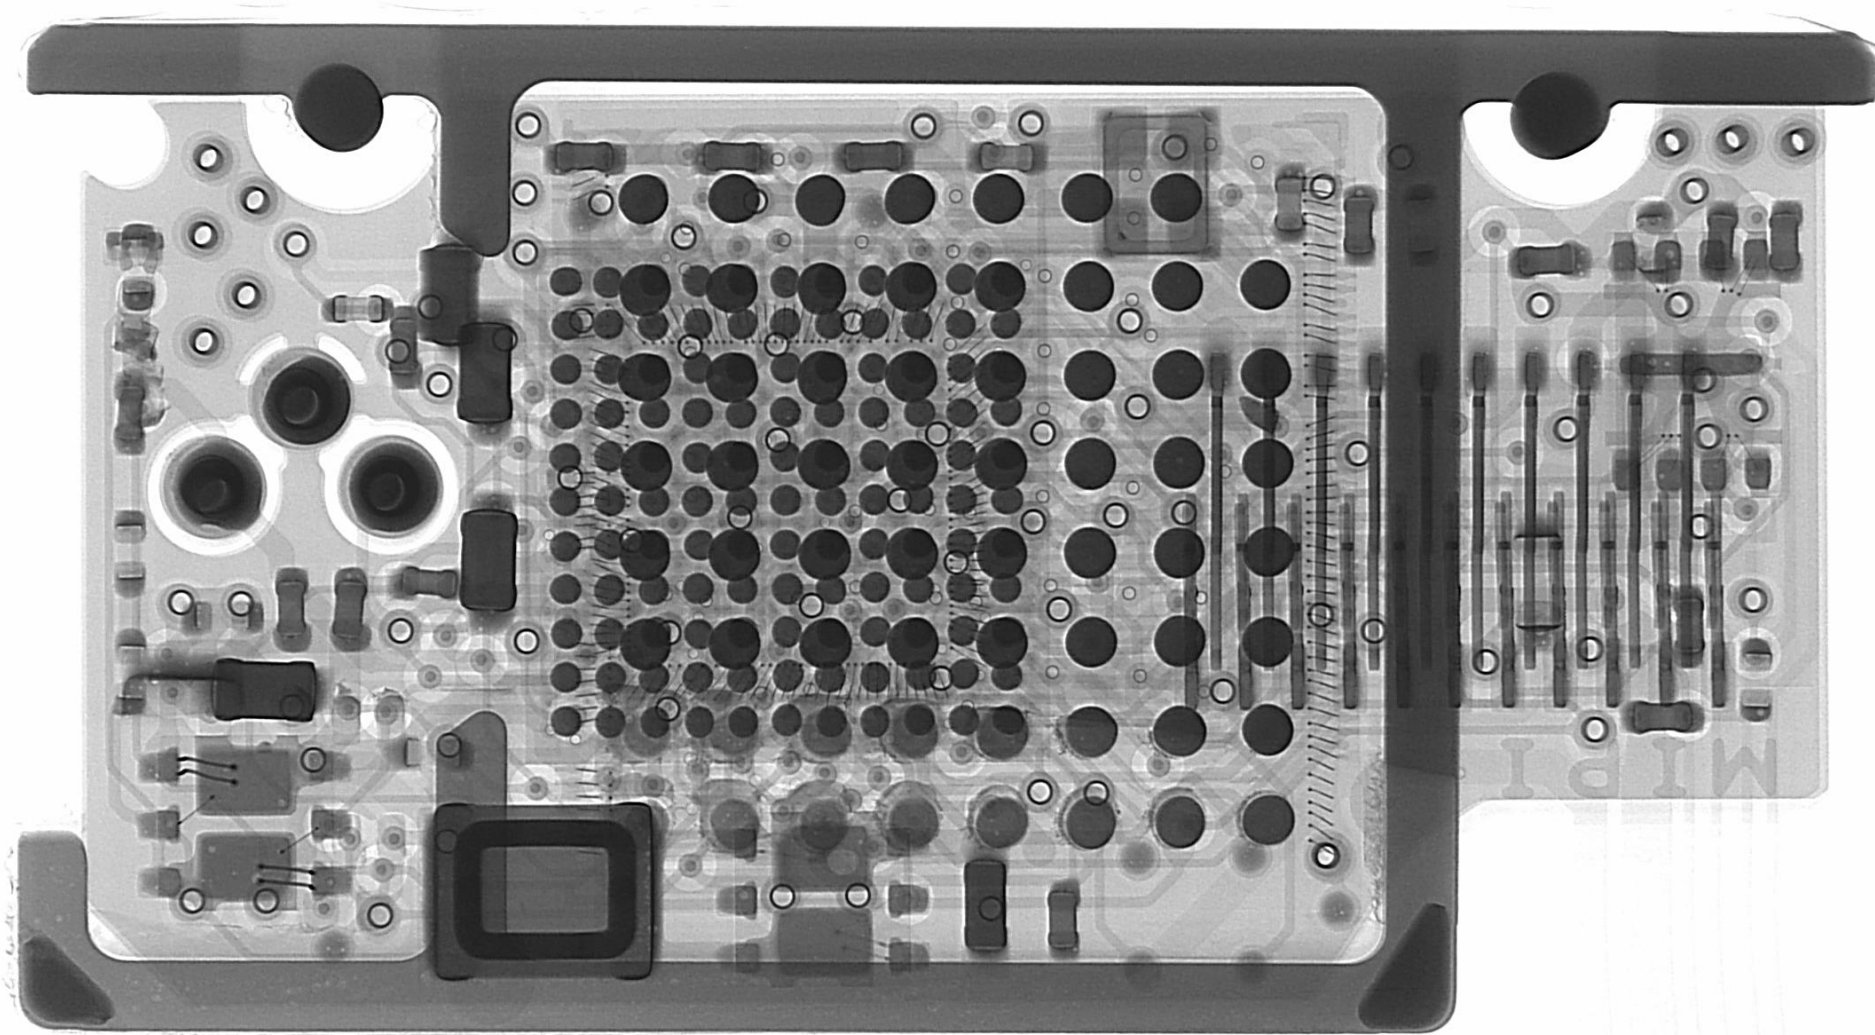
# X-Ray Inspection: No defect/Damages Visible

No misalignment, voids, cracks, clear open or incomplete vias, foreign particles or defects

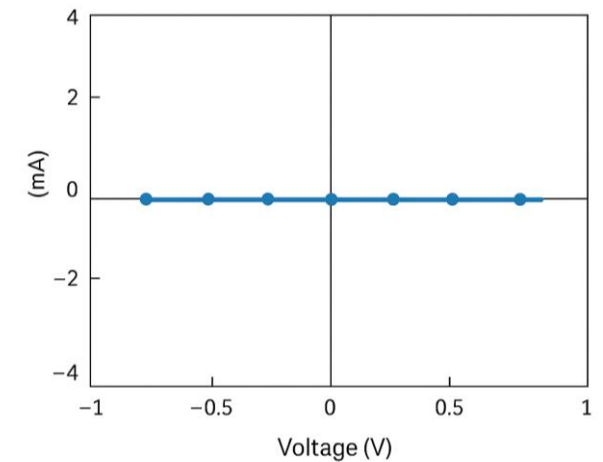
# Electrical Testing: Open at Elevated Temperature

Ohmic contact at room temperature

Open at elevated temperature

## Working Hypothesis:

Possible cracks in a BGA/Trace/microvia along the suspect trace

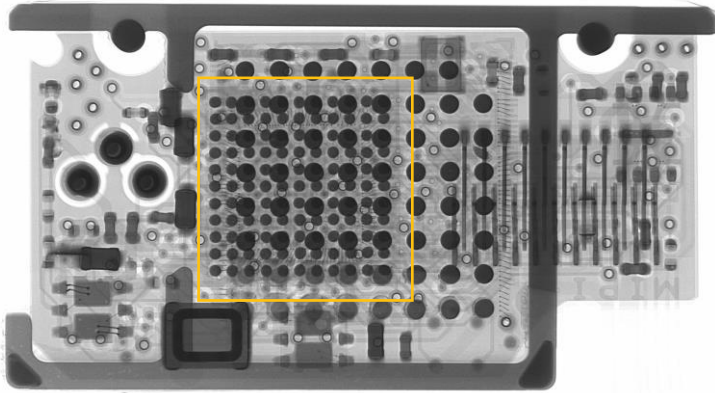
# X-Ray Inspection: Potential Defective Microvias Located

Locating potential defective microvias

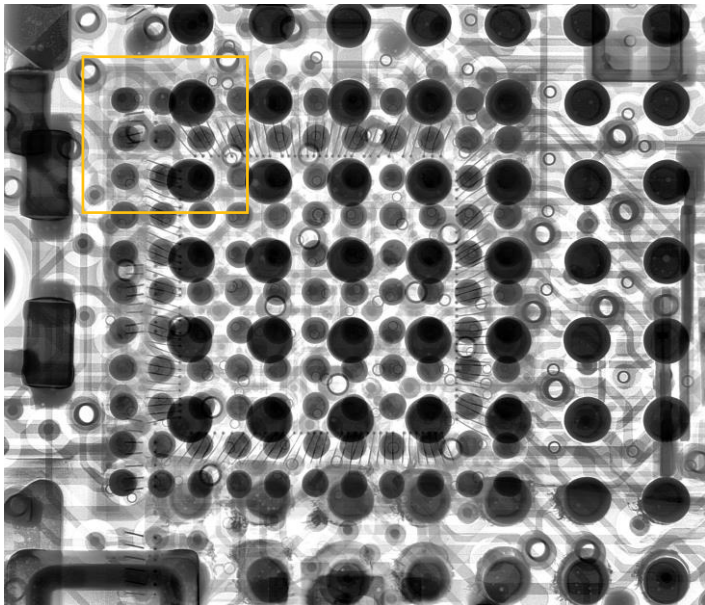
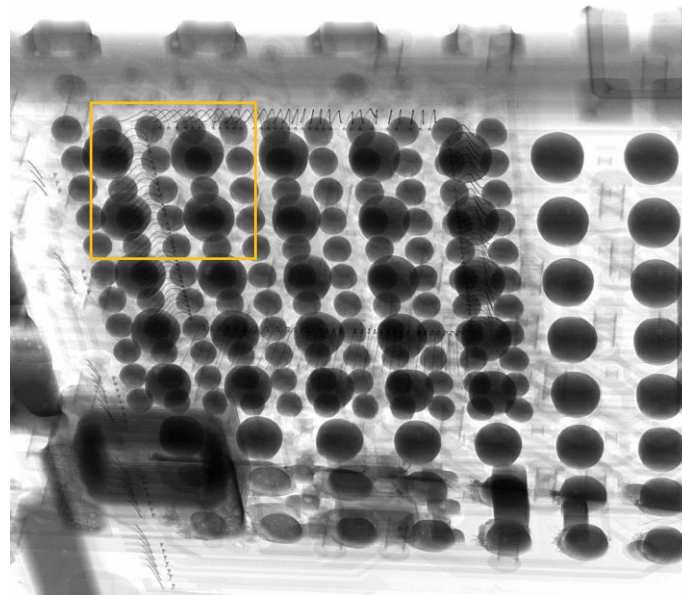
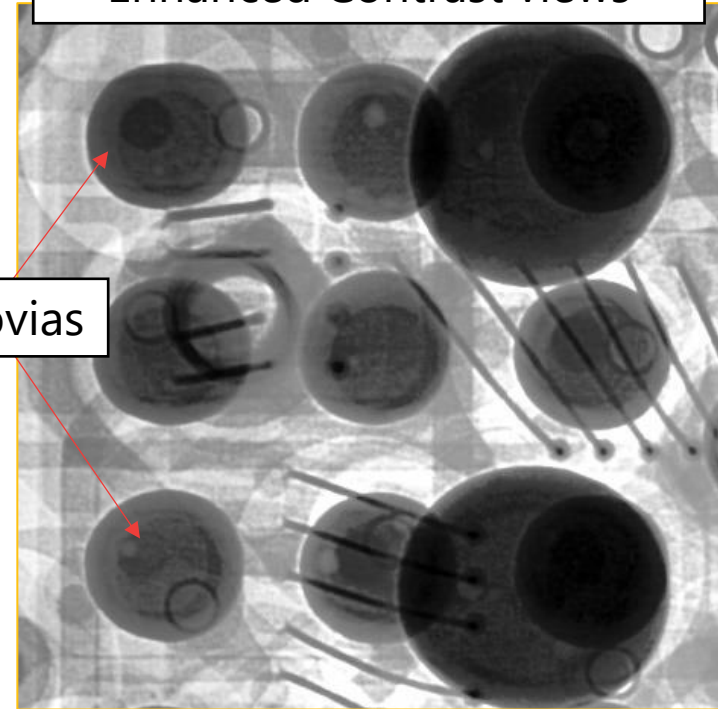
Enhanced Contrast views

Microvias

2D X-Ray can be effective for detecting some microvia defects, but its limitations in depth resolution may necessitate complementary techniques, such as 3D X-Ray (CT) or cross-sectional analysis, for detailed characterization.

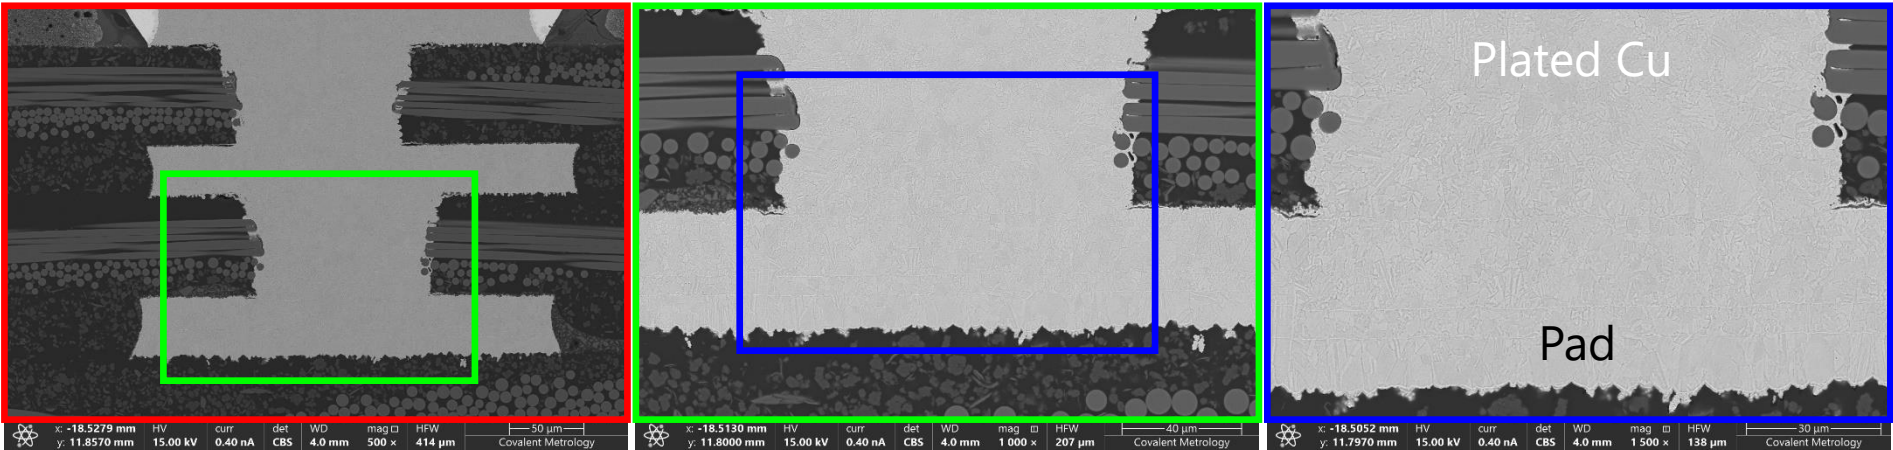
Separation visible

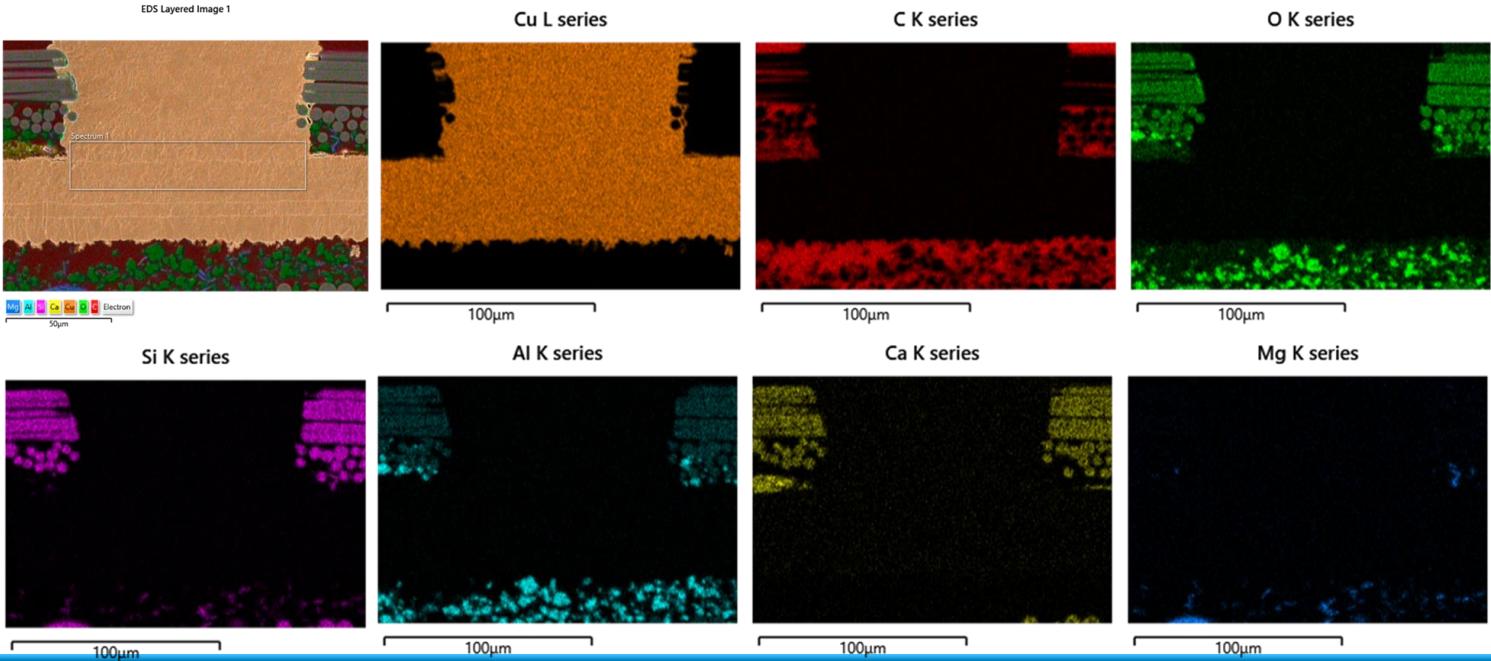
No crack, voids  
delamination or any  
structural  
irregularities.

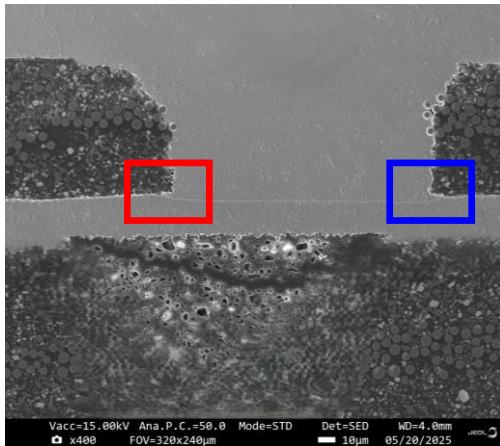
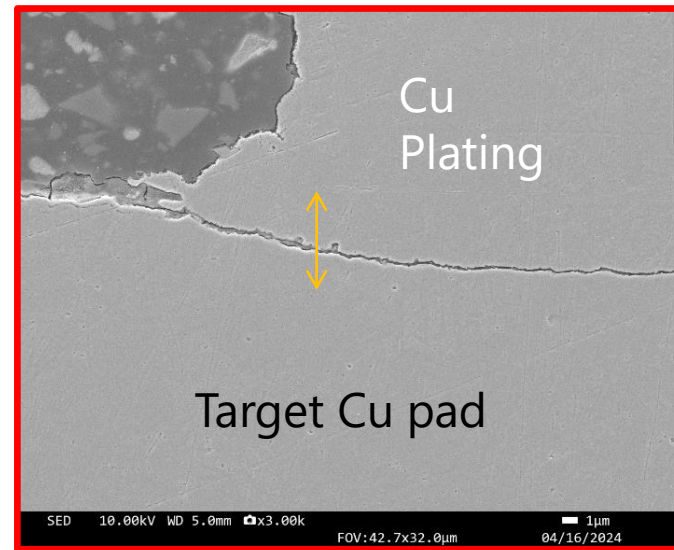
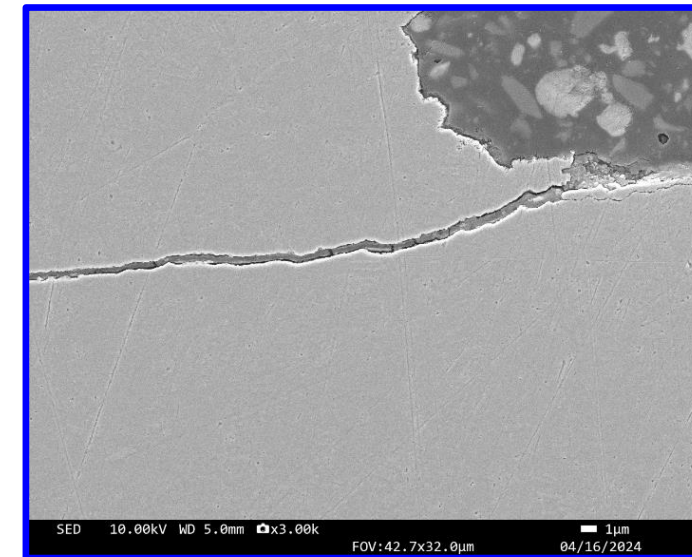
Crack visible – no oxidation/contamination/defect detected with SEM/EDS.

Extract Lamella at the crack location to understand contamination and/or microstructure issue

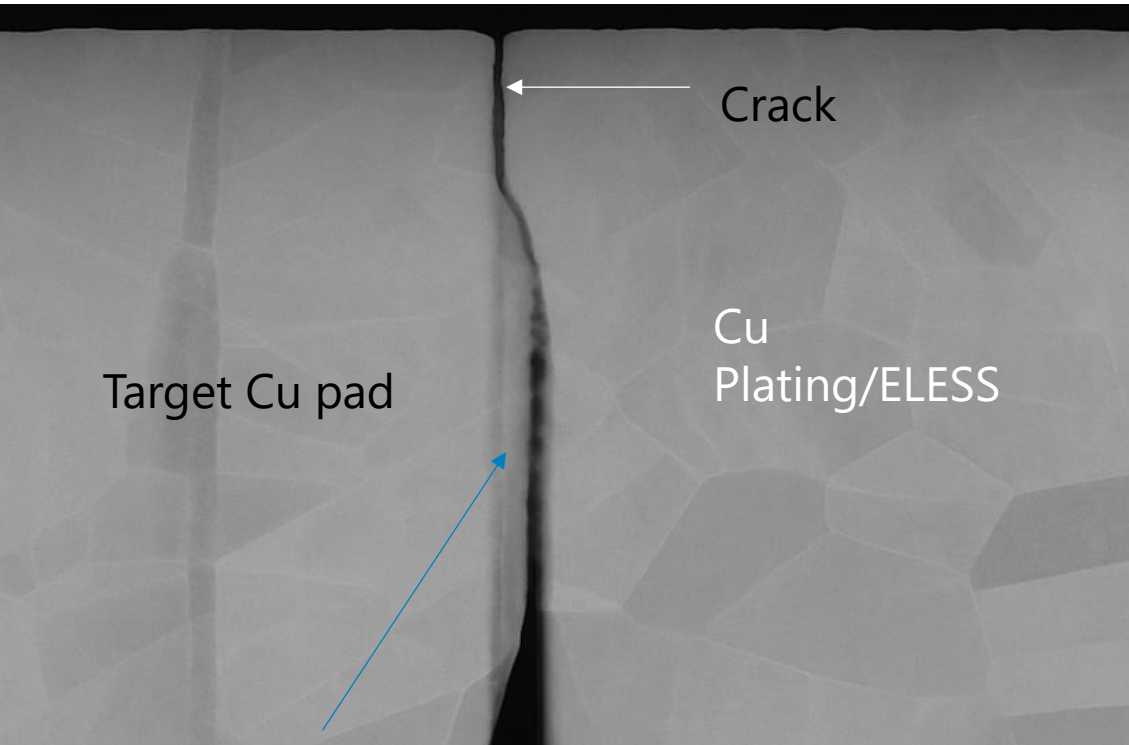
Preparation artifact

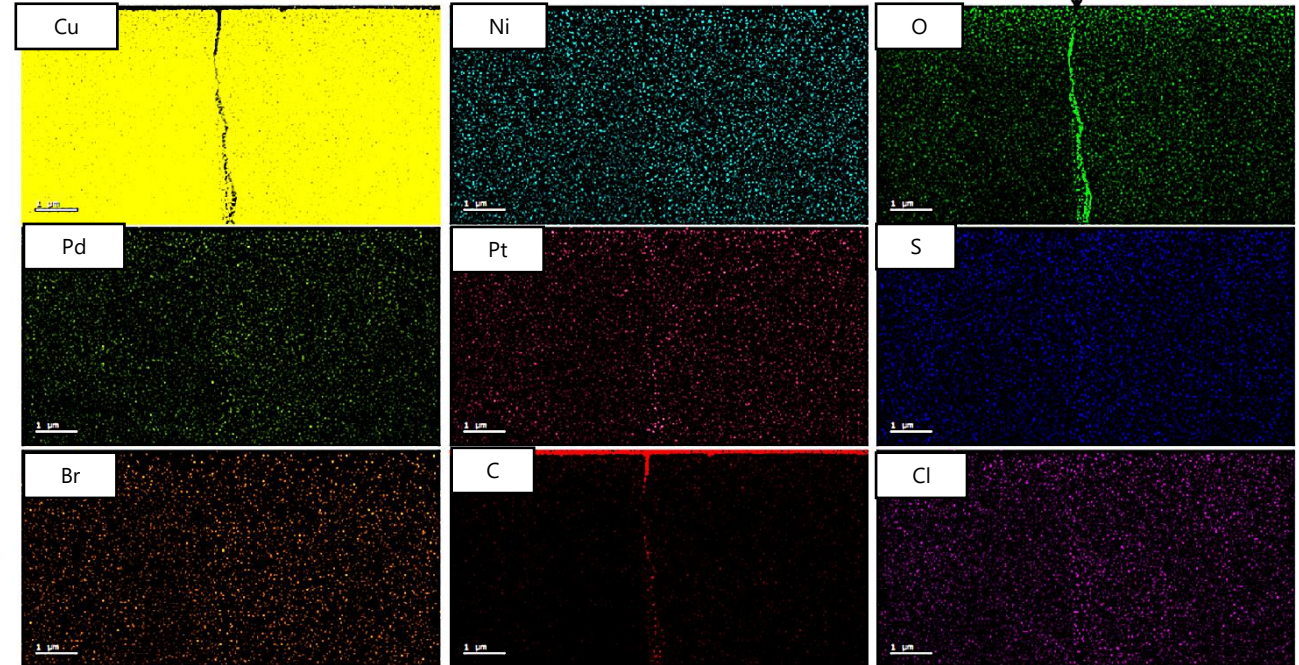
High concentration of oxide present at the crack surface. No Ni or Pd layer typical from ELESS deposition were detected.

- **Root Cause Correlation**
  - Delamination at the interface between the copper plating in the via and the target copper pad led to electrical discontinuities and/or intermittent connections in the circuit.
- **Recommendations**
  - Process variables such as plating process parameters, including current density, bath chemistry, and agitation needed review followed by implementing reliability tests like IST (Interconnect Stress Testing) or highly accelerated life testing (HALT).

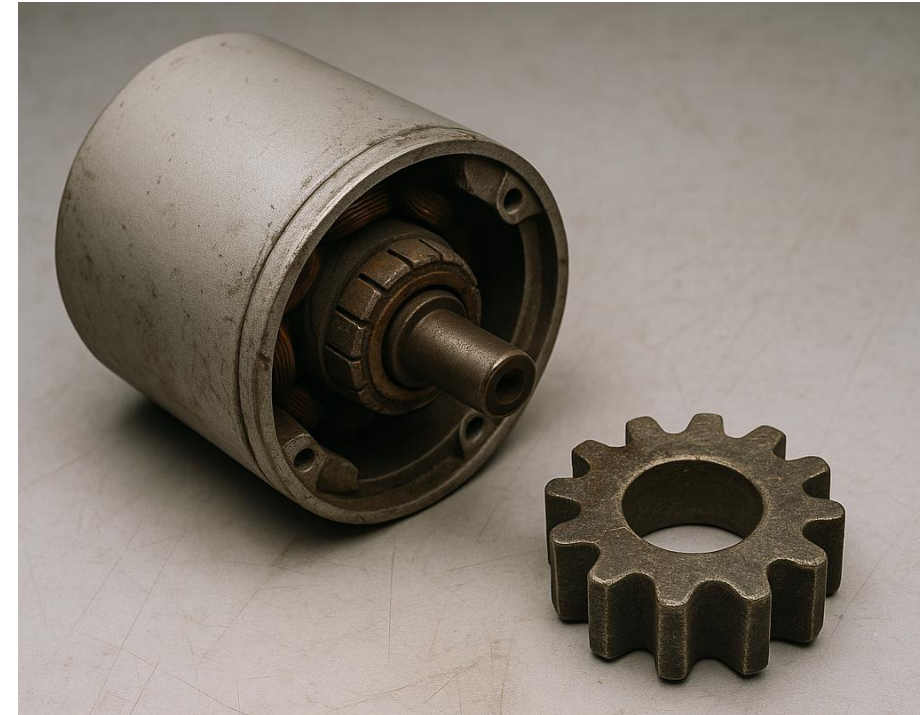
- Generator opened and the following was observed:
  - Windings and shaft intact
  - Debris found inside the housing
  - Debris were found to be magnetic
  - Cracking observed on magnet surface

DC Magnet failed during operation

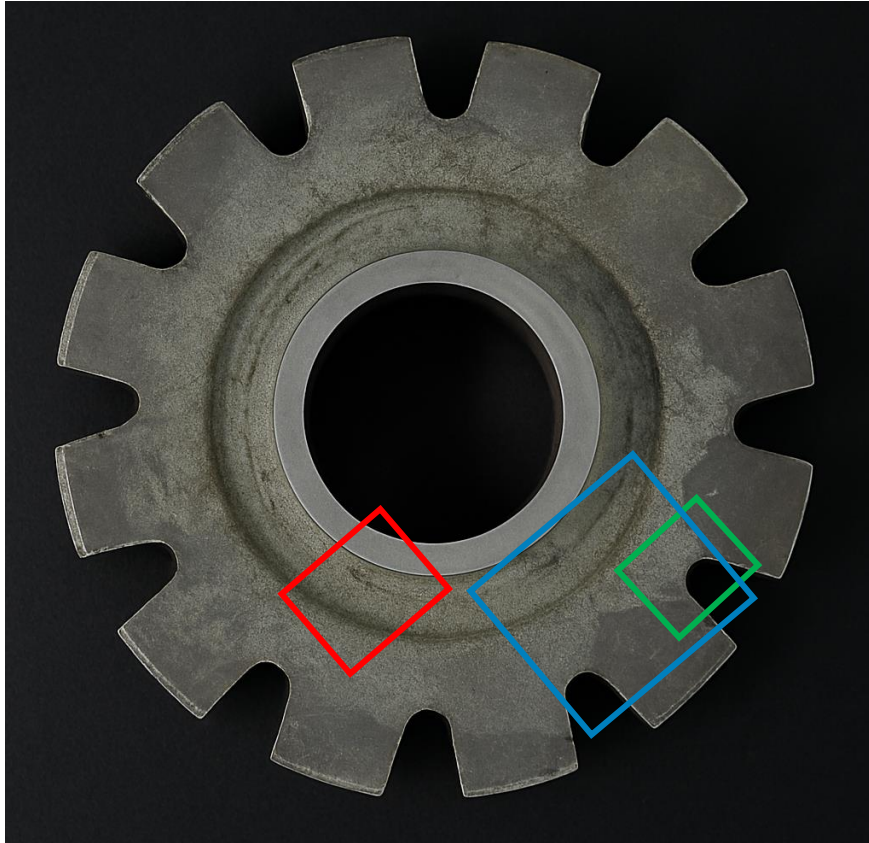
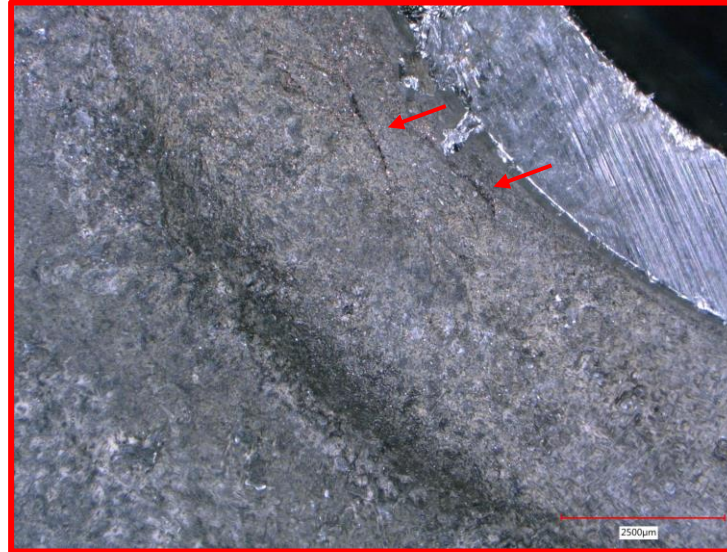
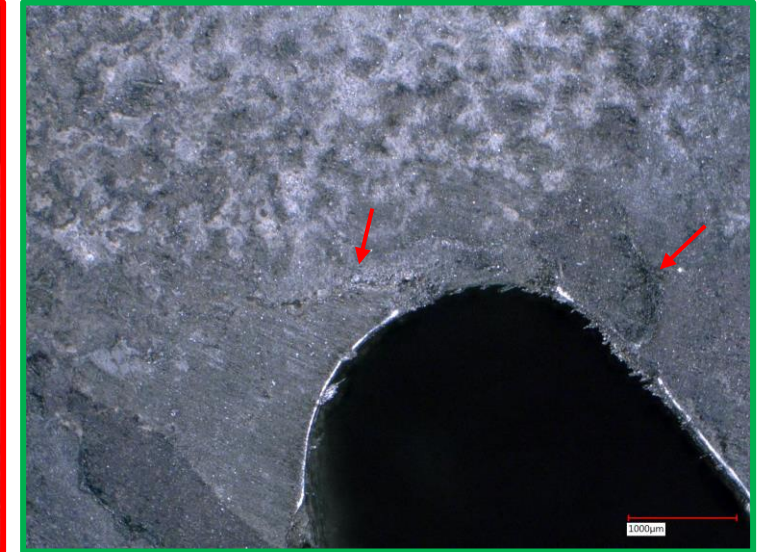
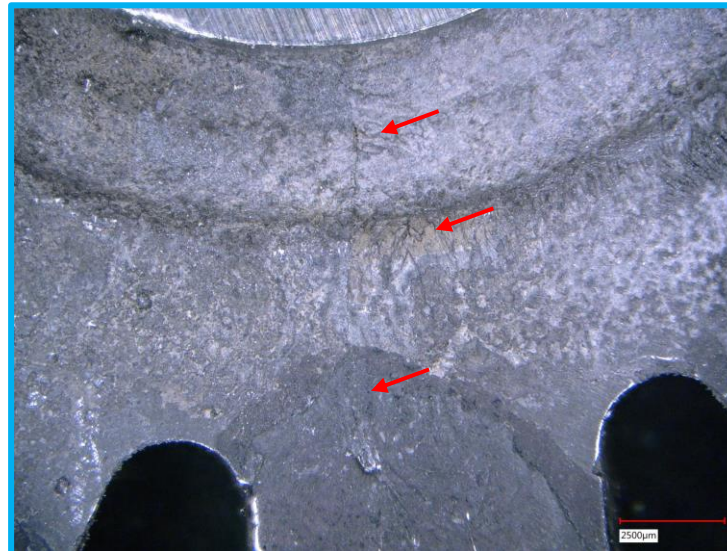
# Optical Inspection of Surface Cracks

- Several **cracks** were found in the bulk of the magnet.
- To investigate the depth and severity of the cracking, mechanical cross-section, and cryofracture analysis were performed on the magnet.

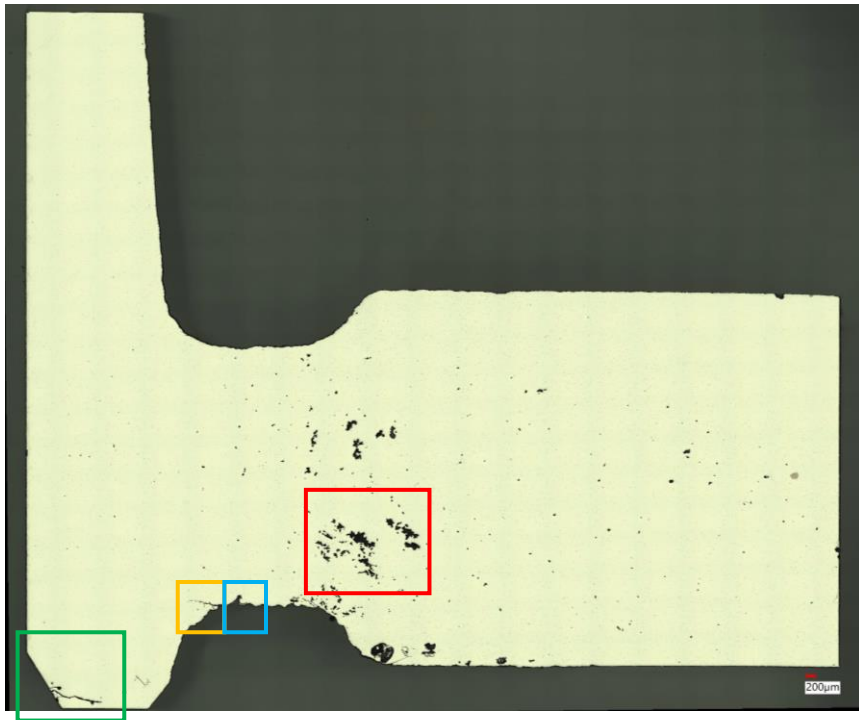
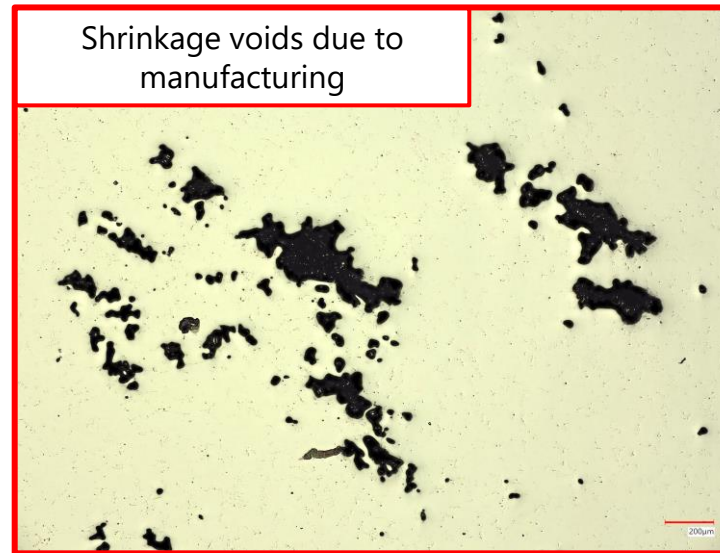
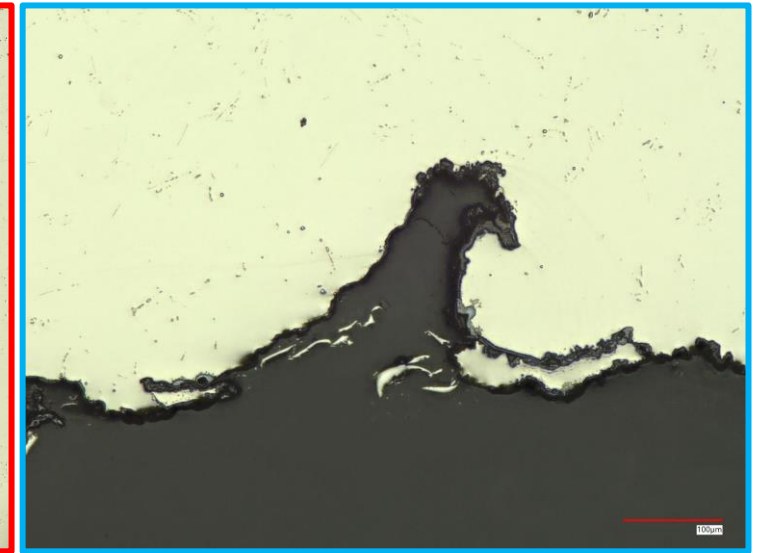
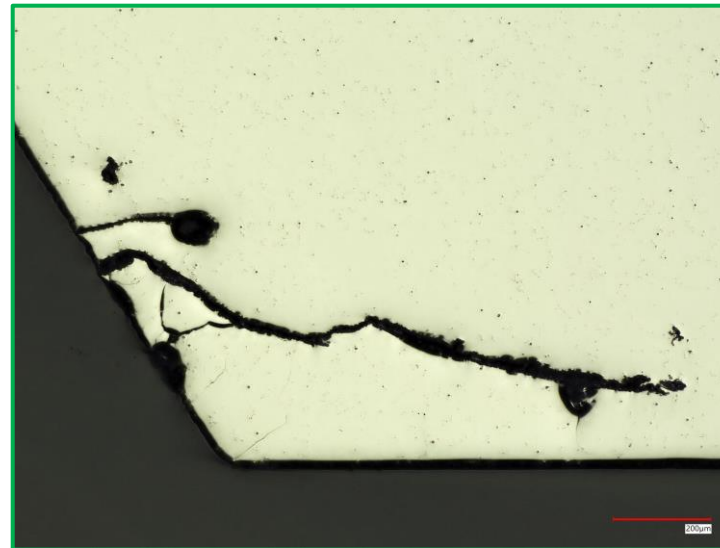
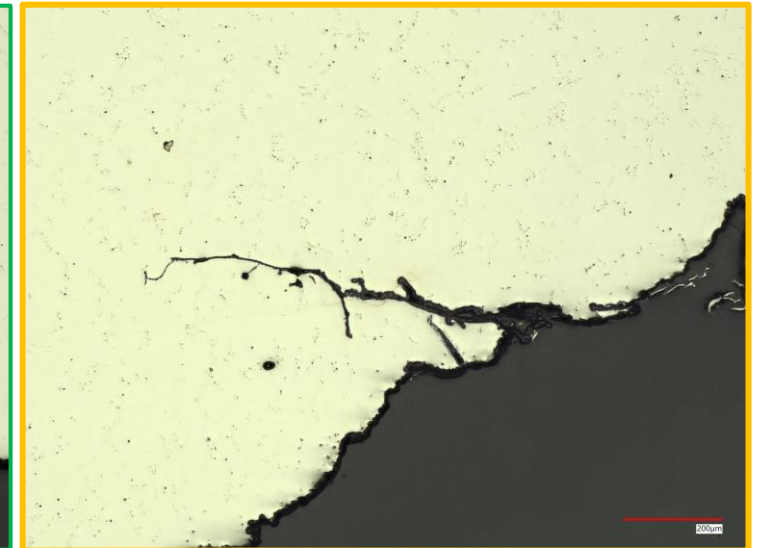
Several **cracks** were observed in the magnet near the edges of the cross-section

**Shrinkage voids** visible and are likely due to improper temperature process control (uneven cooling or too fast cooling)

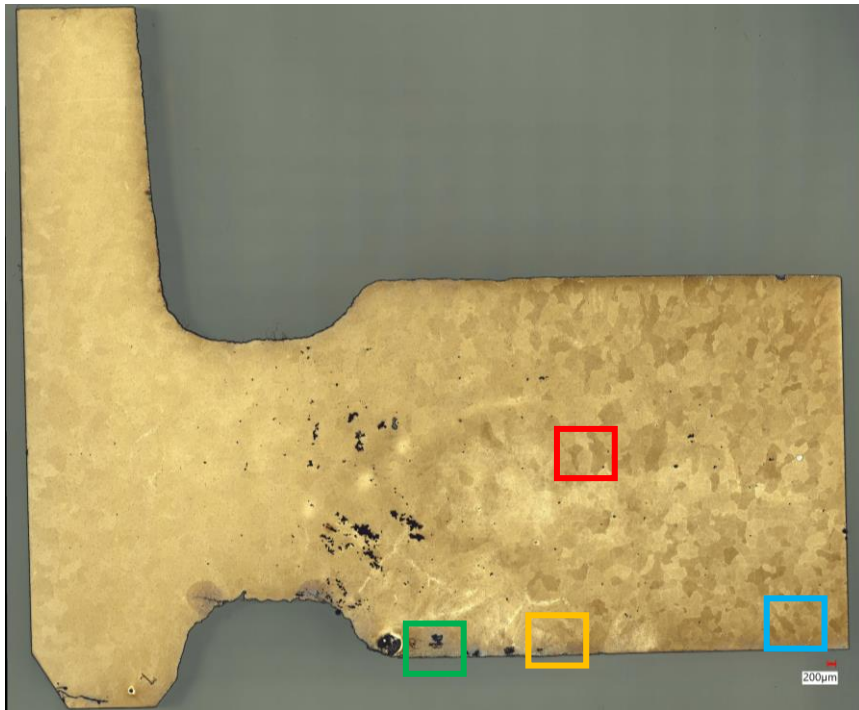
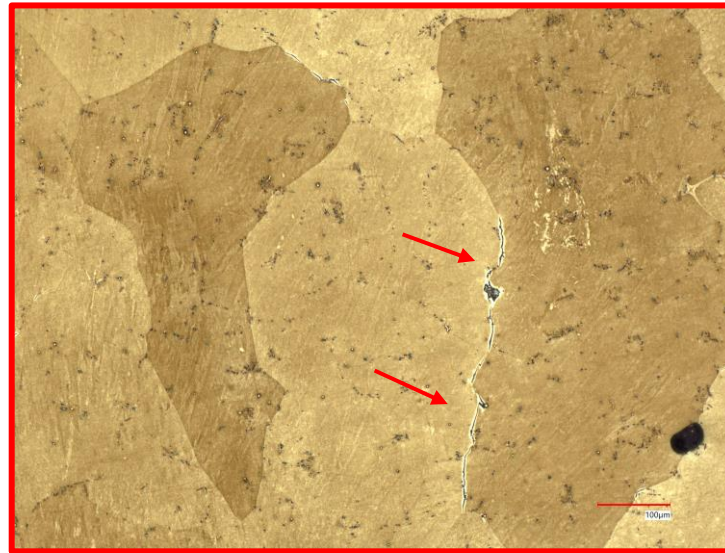
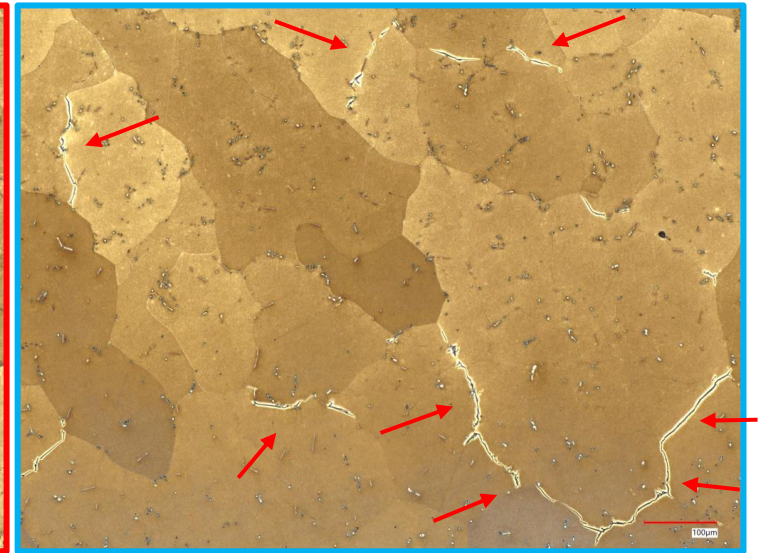
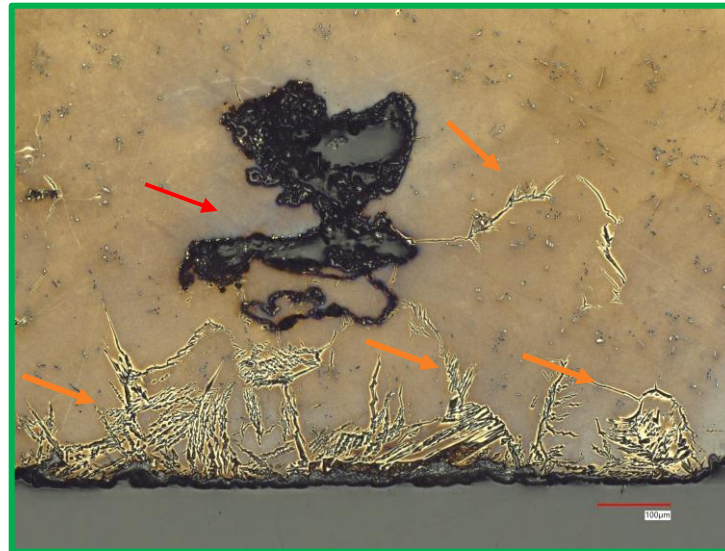
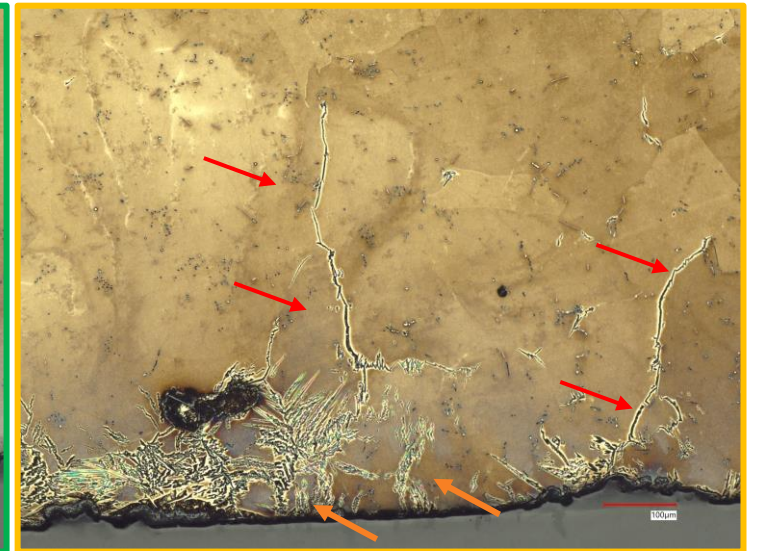
- **Intergranular cracking** was observed throughout the magnet
- **Transgranular cracking** near the edges of the magnet – these often points to fatigue or stress corrosion cracking

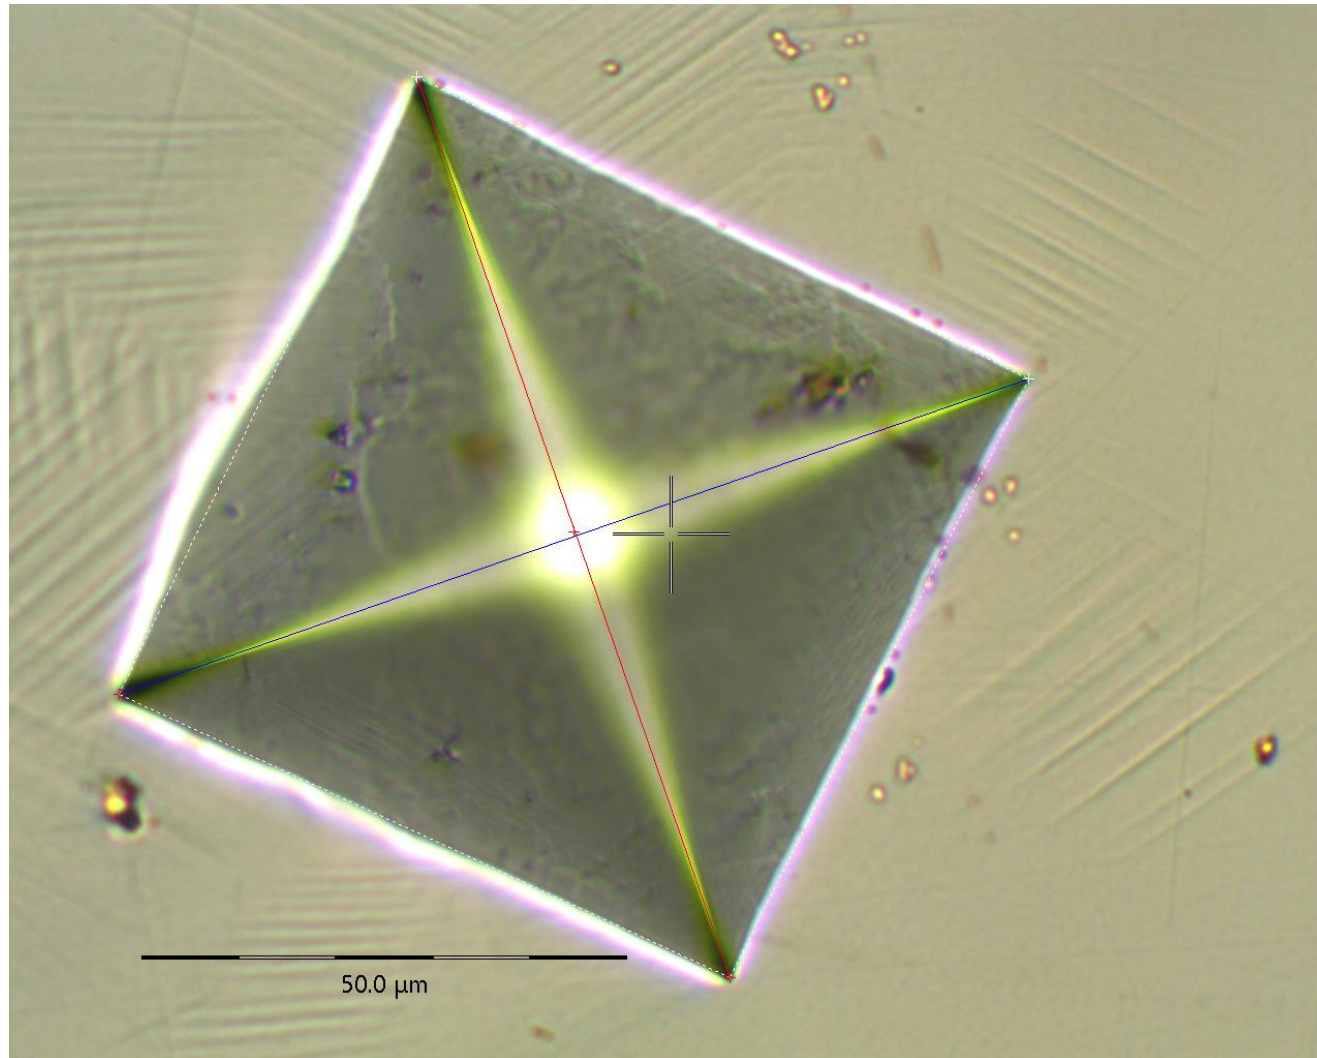
Hardness: 590.59 HV

- The established Vickers hardness of alnico falls within the range of 520 - 700 HV
- The HV of the magnet is within the accepted specification

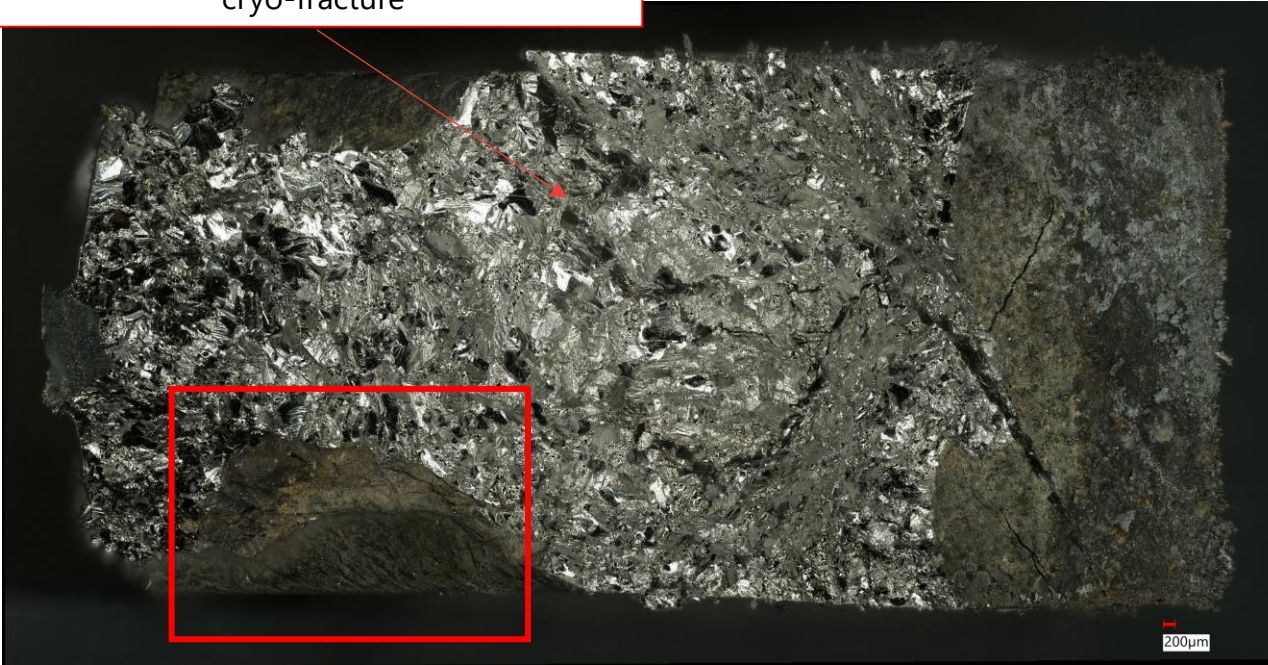
Brittle fracture surface exposed from the cryo-fracture

- Surface appearance differs from the crack surface to the material bulk
- Likely corroded surface was exposed from the cry-separation, indicating pre-existing cracks stemming from the magnets surface.

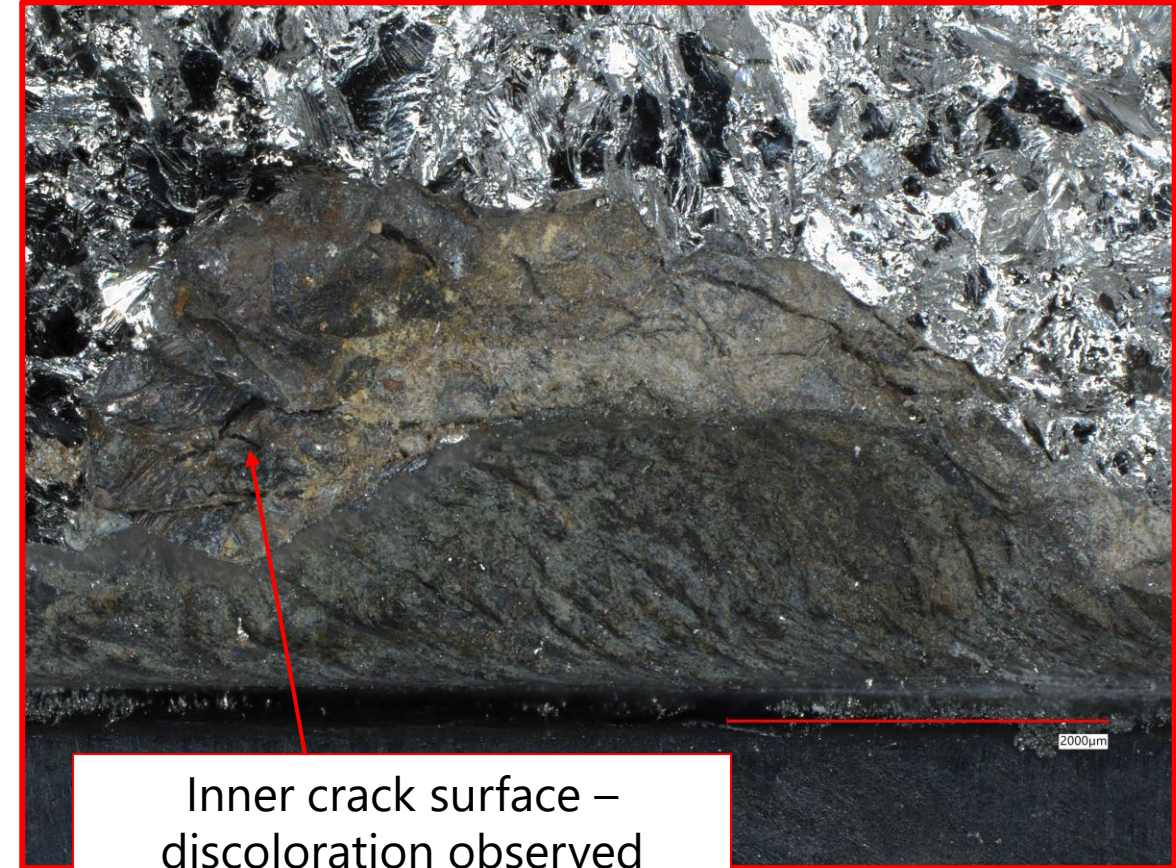
Inner crack surface –  
discoloration observed
