# From Malfunction to Solution

*Advanced Failure Analysis for  
Materials & Electronics*

Industrial Applications of  
Advanced Metrology  
Episode 44

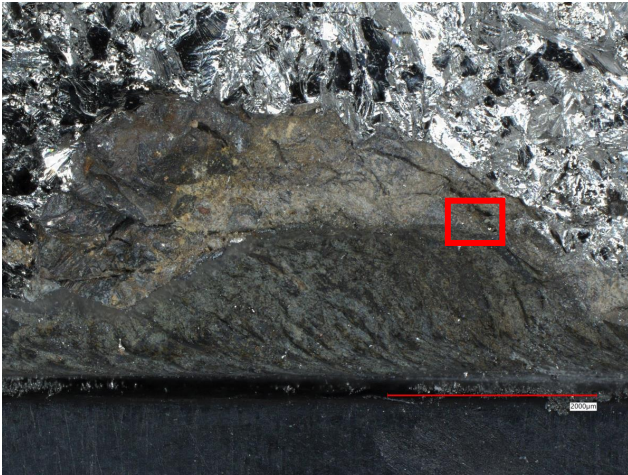
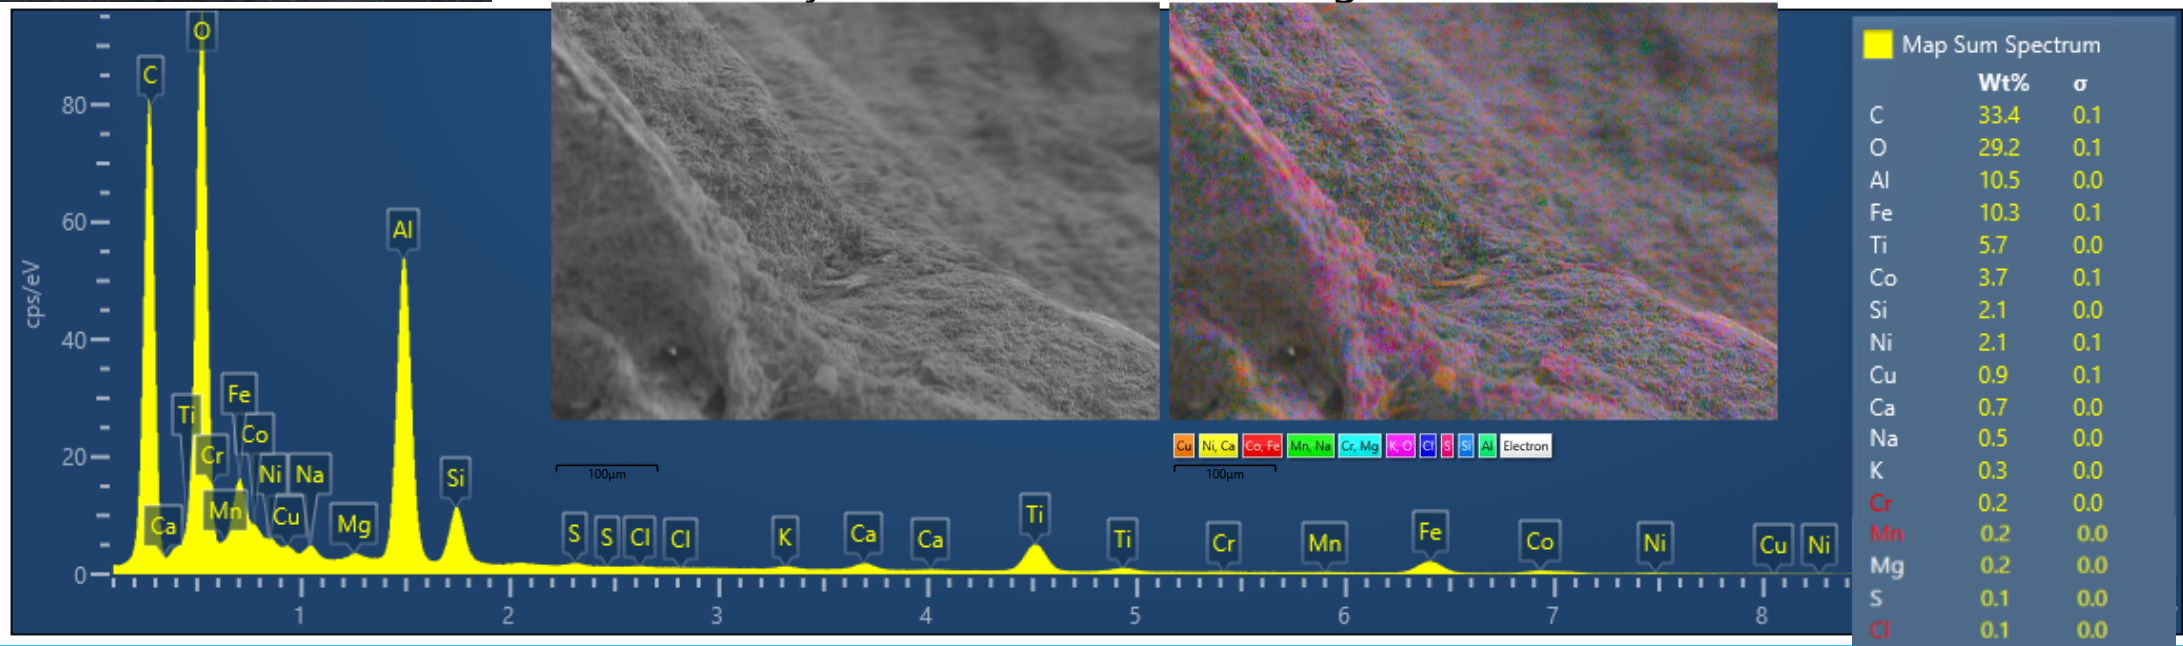
- SEM/EDS data were taken in the area covered in suspected corrosion product
- **O** concentration is higher than the cryo-fracture control surface, 29.2% compared to 1.6%.
- **Ca, Na, K, and Cl** were found on the surface and are indicative of the presence of corrosive species
  - The presence of these elements and elevated oxygen levels corroborates the hypothesis that the cracking observed near the edges of the sample is likely stress corrosion cracking

- **Root Cause Correlation**
  - Material composition is slightly off specs and could be related to composition drift, segregation.
  - Transgranular and intergranular cracking observed near surface and in the bulk of the magnet
  - Analysis suggests creep and stress corrosion cracking
  - Component failure due to material degradation, thermal cycling, and corrosion
- **Recommendations**
  - Manufacturing: Use tougher magnet material or protective coating to reduce brittleness (SmCo, NdFeB, Alnico 8/9 – need to understand environment needs to support decision
  - Improve mounting design (mechanical support / adhesive bonding to minimize vibration-induced stress)
  - Add vibration/thermal cycling qualification testing for future designs
  - Include predictive maintenance checks (flux density + vibration monitoring)

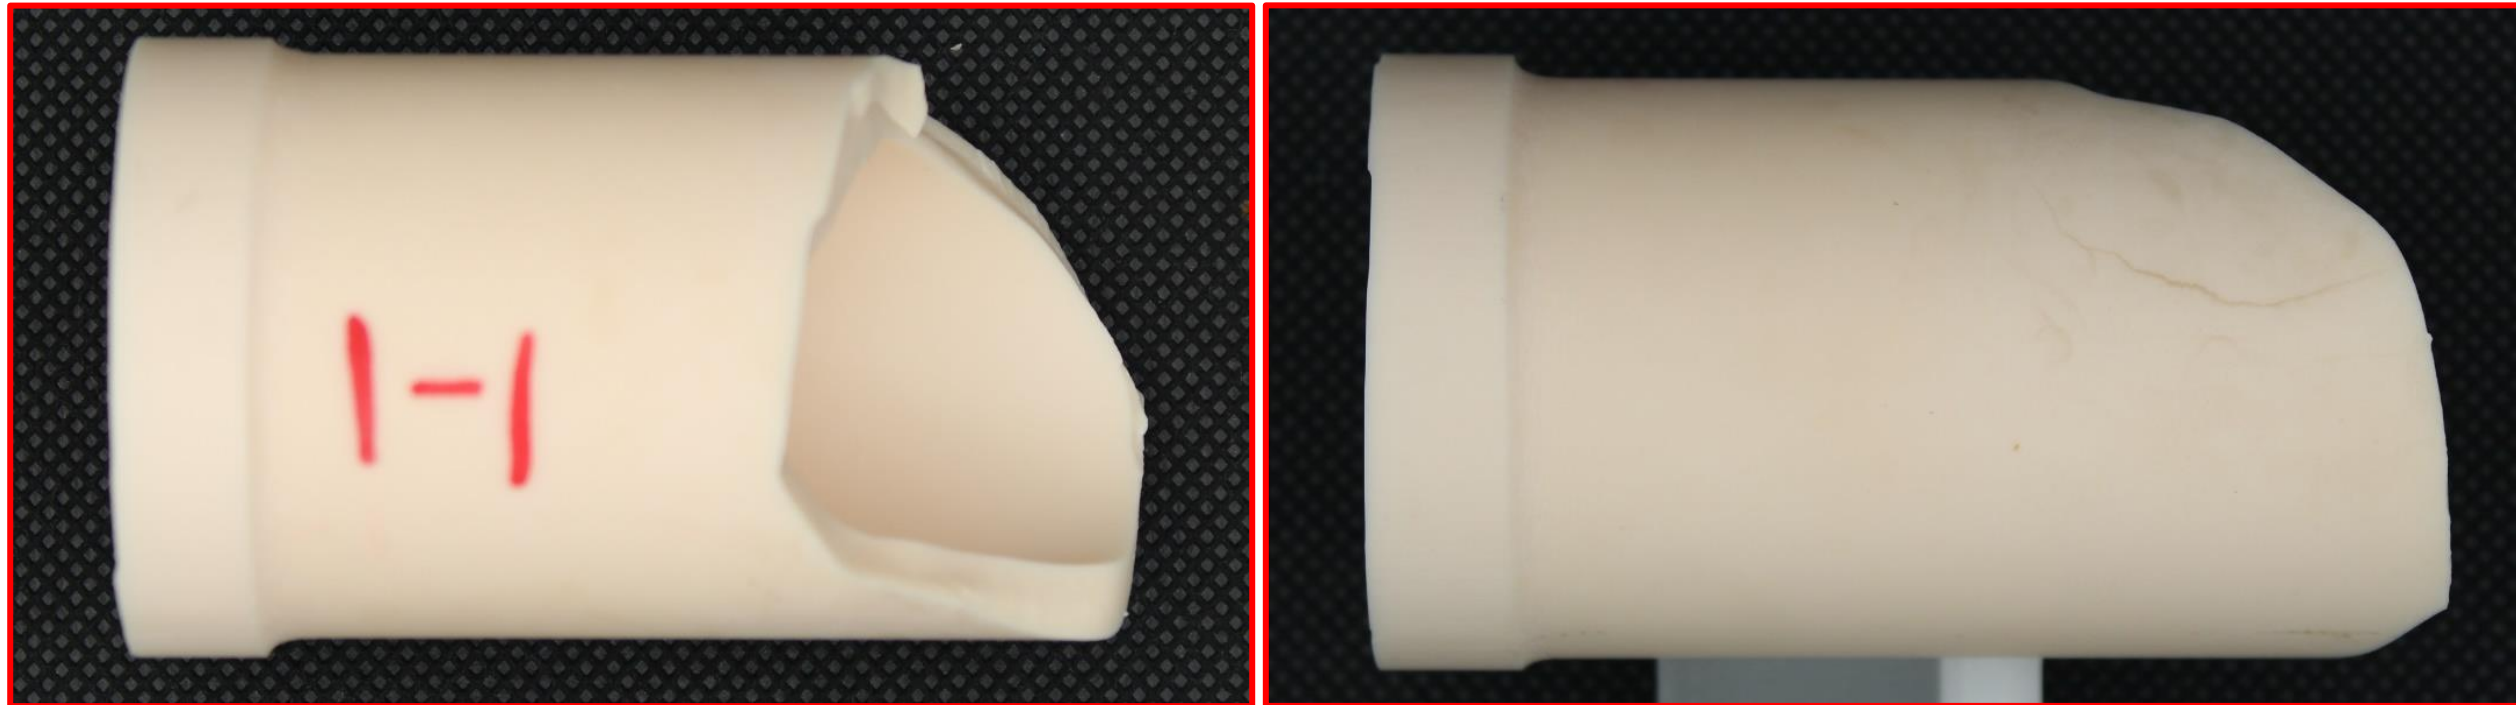
Photo documentation of the fracture furnace tube highlighting the mating half of the fracture utilized for optical and electron microscopic examination.

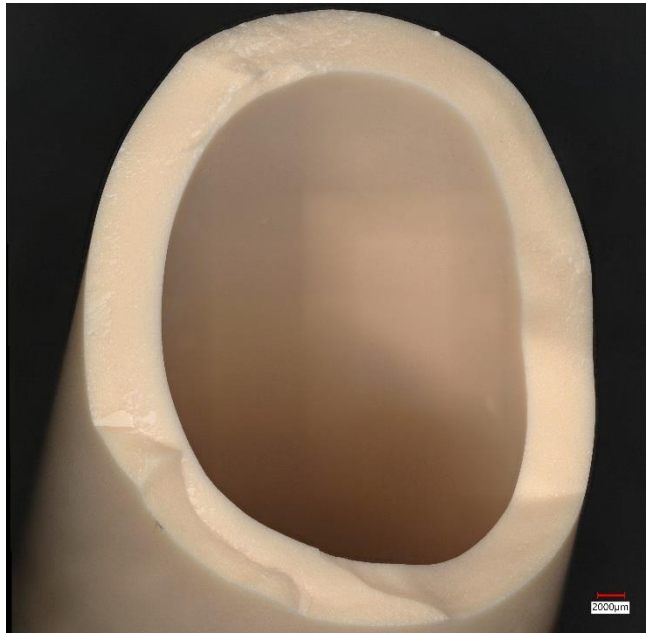
Optical image of the region of initiation where a defect can be seen on the outer edge of the fracture surface.

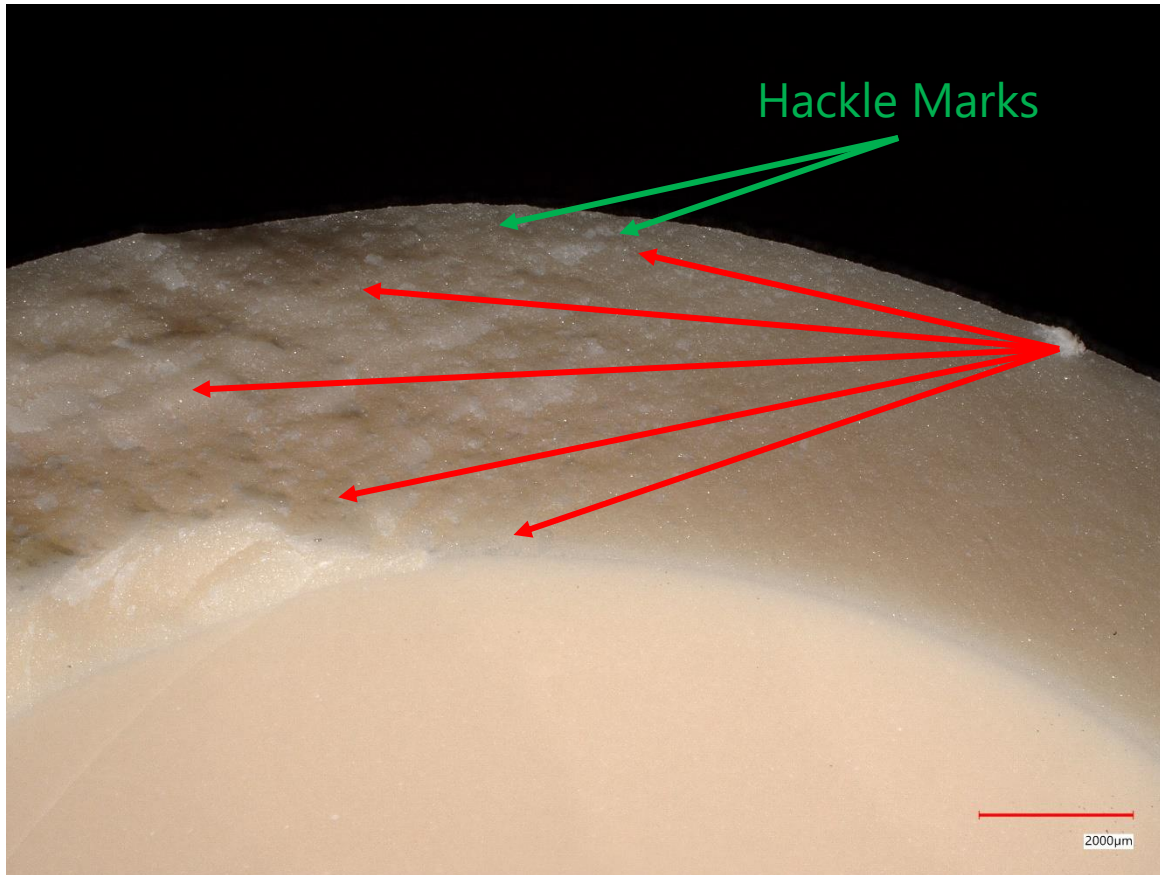
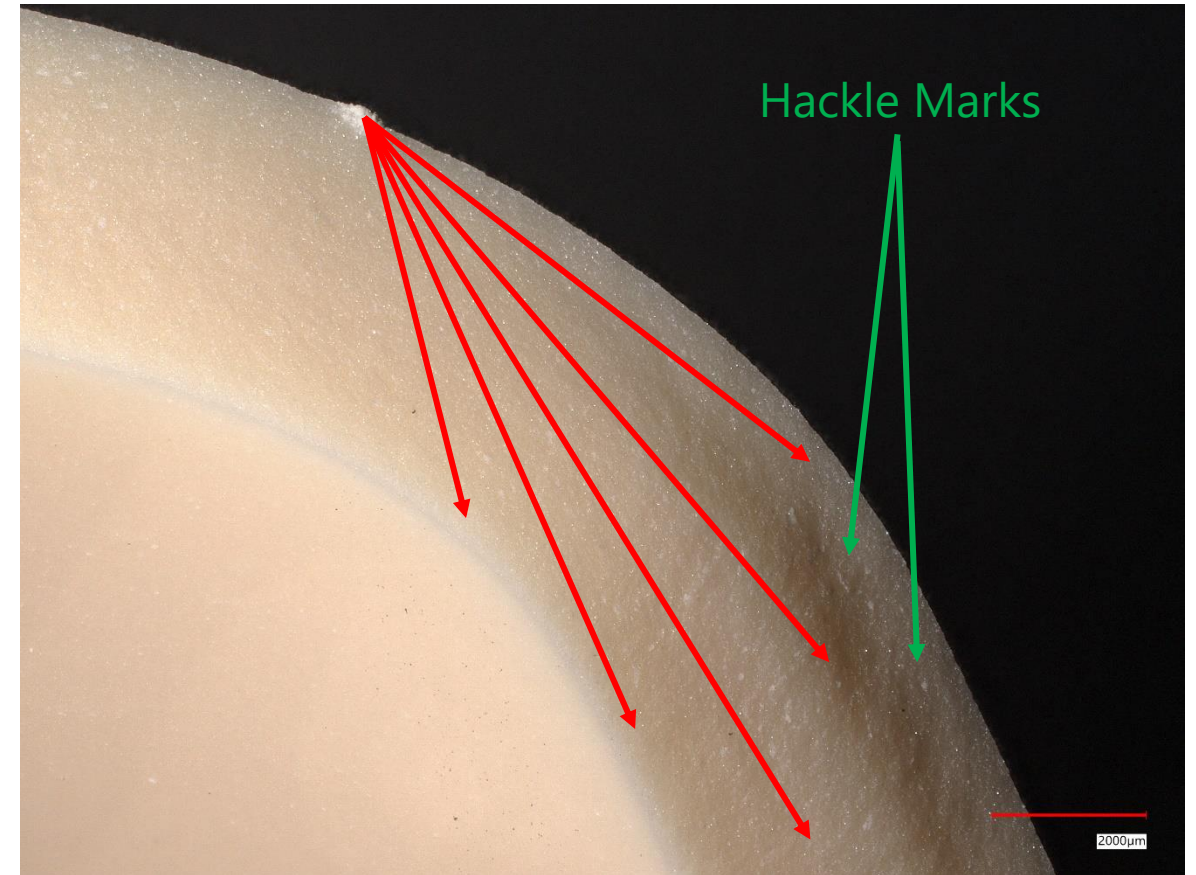
Optical image of the region of fracture initiation in different lightings to highlight hackle marks indicative of the direction of propagation. The red arrows show the direction of propagation starting from the defect.

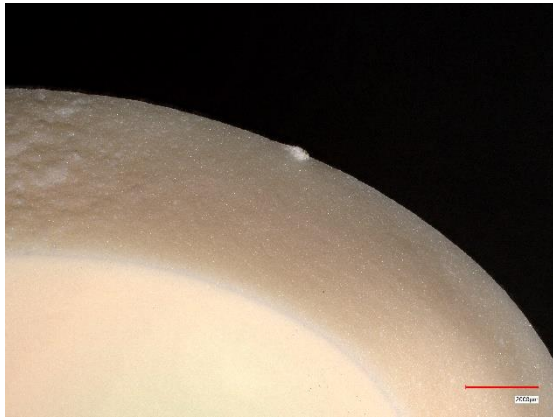
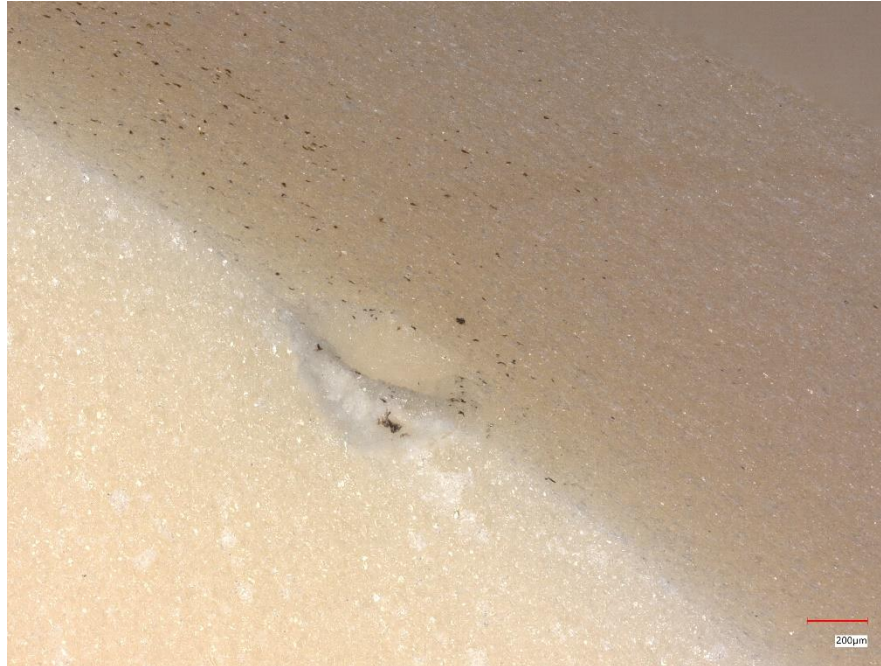
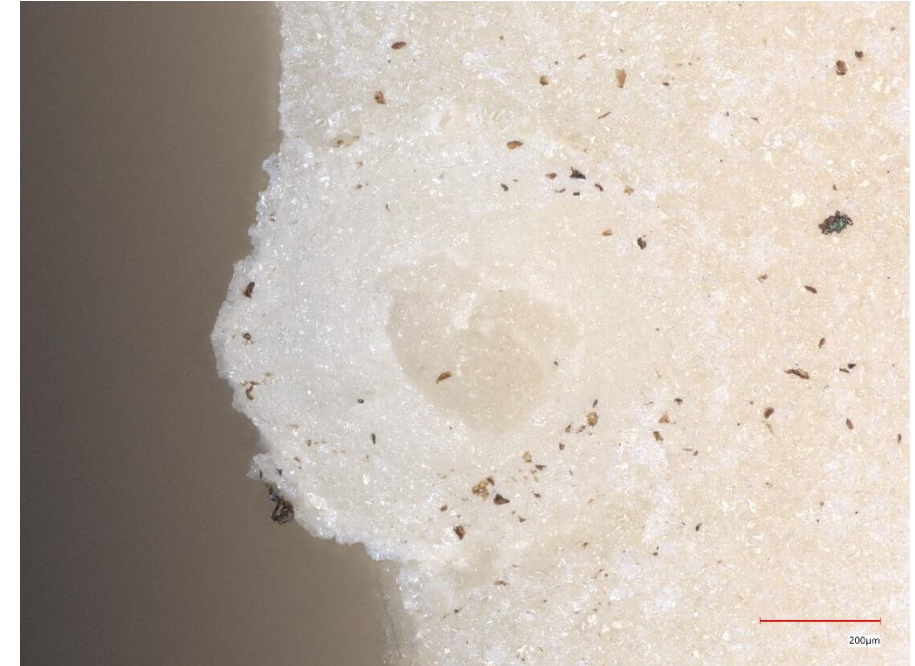
Optical images of the defect where the fracture originated. The defect appears to be some kind of cavity or pore, which would serve as a stress concentrator where cracking or fracture is more likely to initiate.

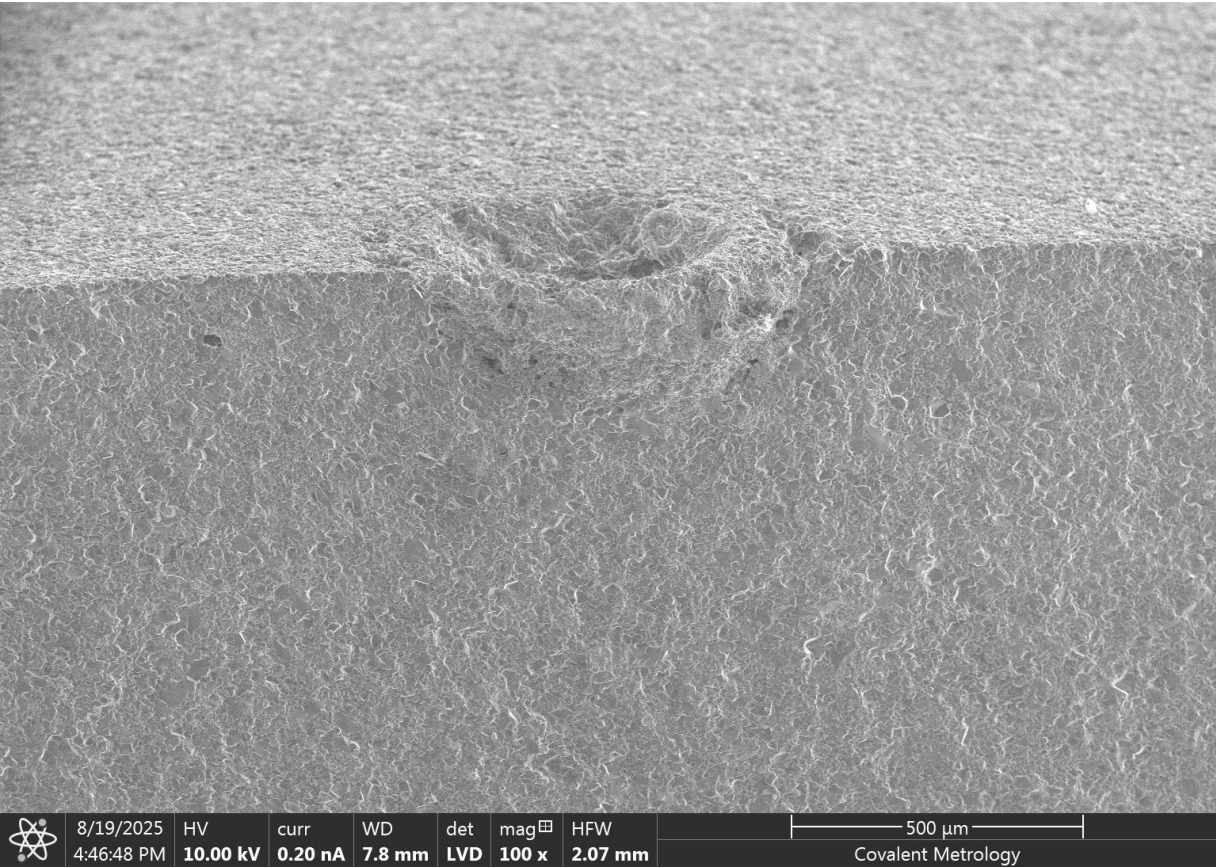
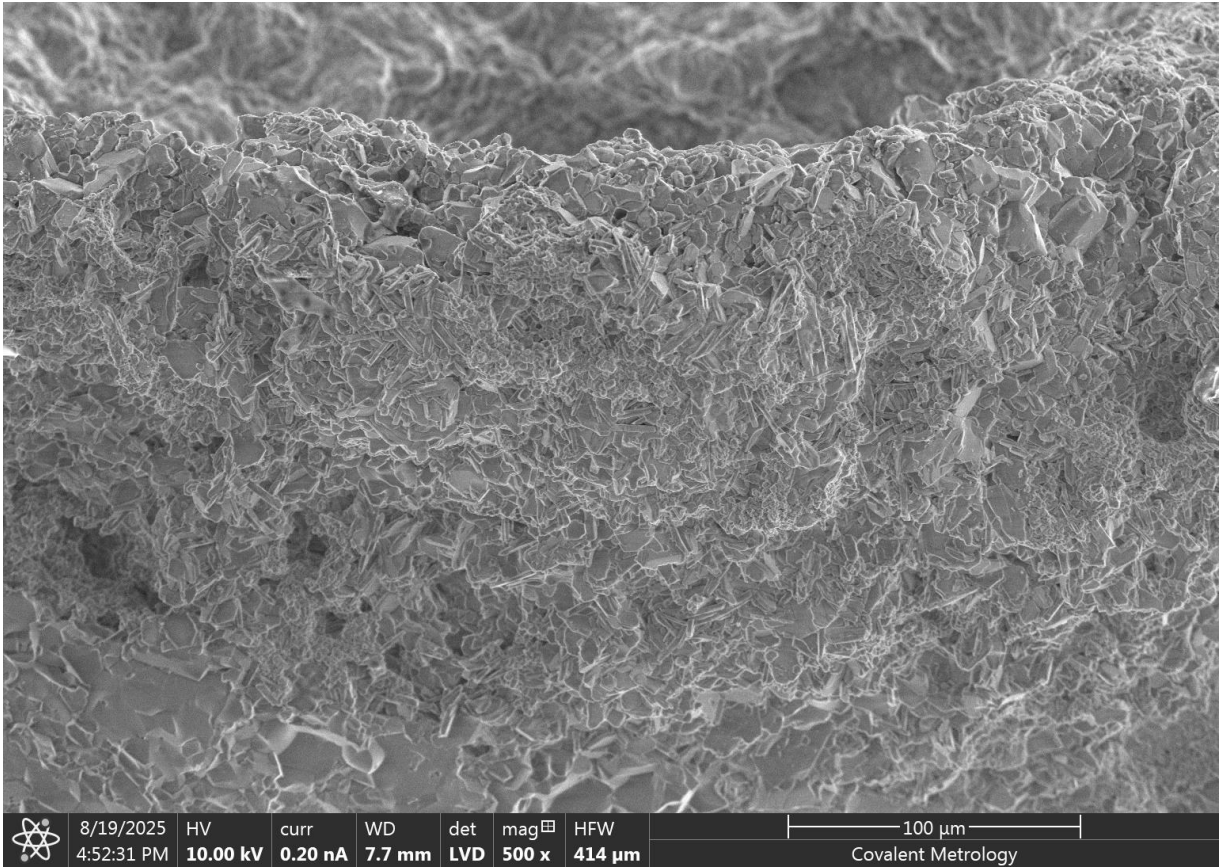
Scanning electron micrographs of the defect where the fracture originated. The variation in grain size and structure is indicative of incomplete sintering or a manufacturing defect.

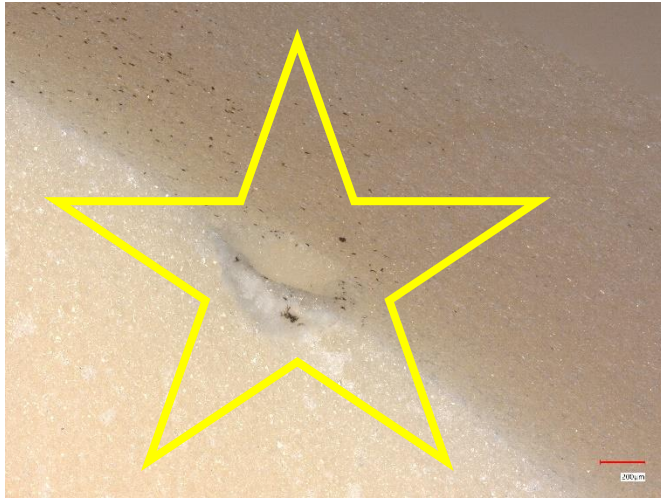
The fracture appears to have originated on the outer surface of the furnace tube where a cavity or pore was observed. The yellow stars indicate where the fracture initiated. The crack propagated outwards from the origin until the tube fractured. Based on the smooth morphology of the fracture surface, it is likely that the fracture took place in an instant.

- **Root Cause Correlation**
  - Localized stress concentration from pore formation during manufacturing.
  - Brittle failure due to the localized stress, from porosity and heating of the tube, exceeding the stress required for fracture to initiate
- **Recommendations**
  - Manufacturing: Pores such as the one observed on the failed sample are commonly associated with incomplete sintering or pore forming agents. Investigation into the sintering profile and presence of pore forming agents could help to negate pore formation.
  - Quality Check: Samples should be visually inspected post-manufacturing to look for pores and inclusions that may result in failure when furnace tubes are exposed to in service conditions.
