# From Malfunction to Solution

*Advanced Failure Analysis for  
Materials & Electronics*

Industrial Applications of  
Advanced Metrology  
Episode 44

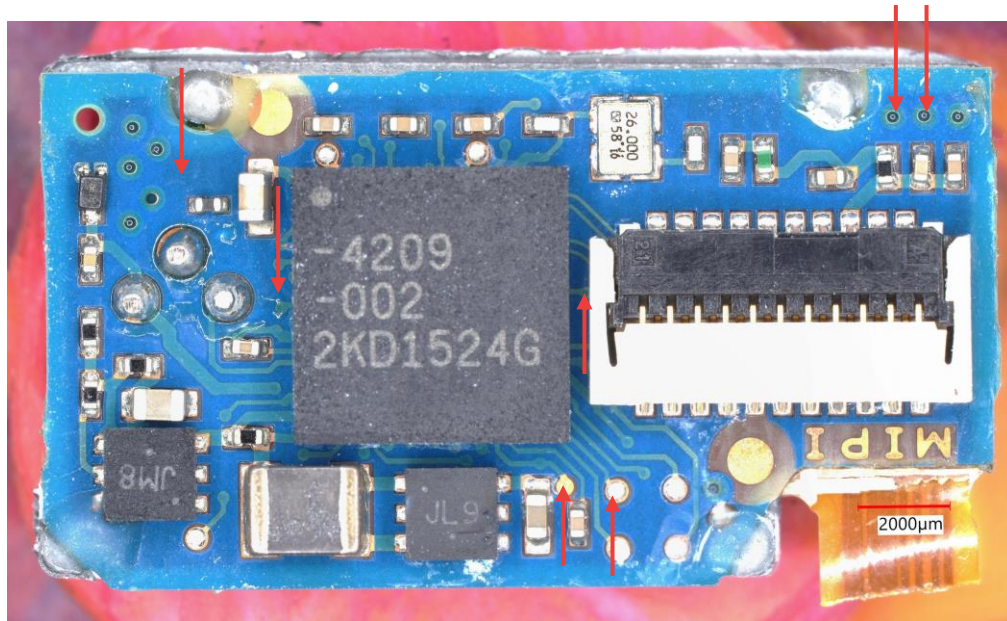
Ohmic contact at room temperature

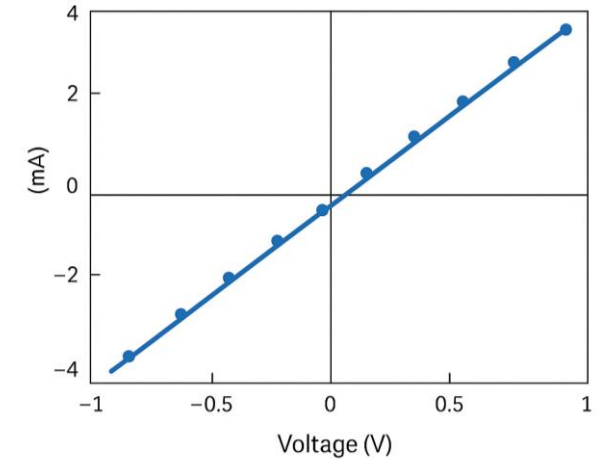
Open at elevated temperature

Possible cracks in a BGA/Trace/microvia along the suspect trace

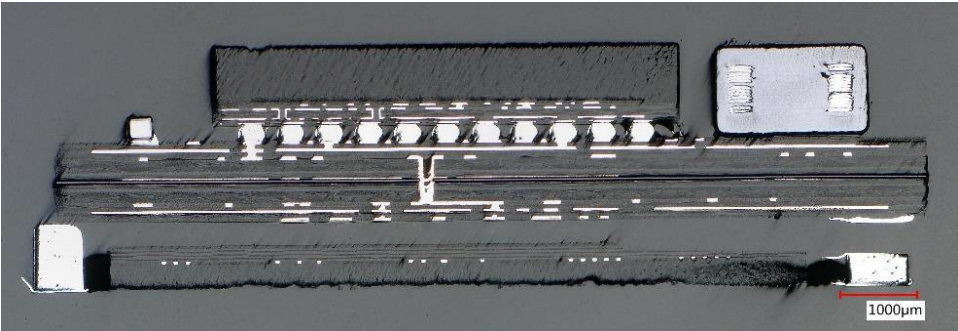
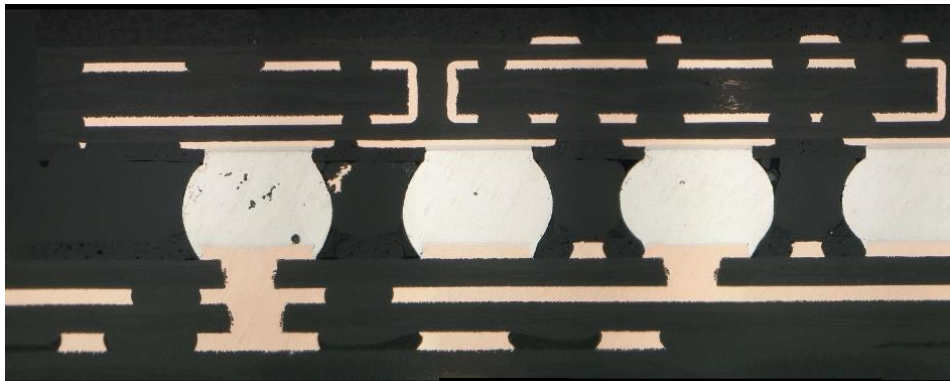
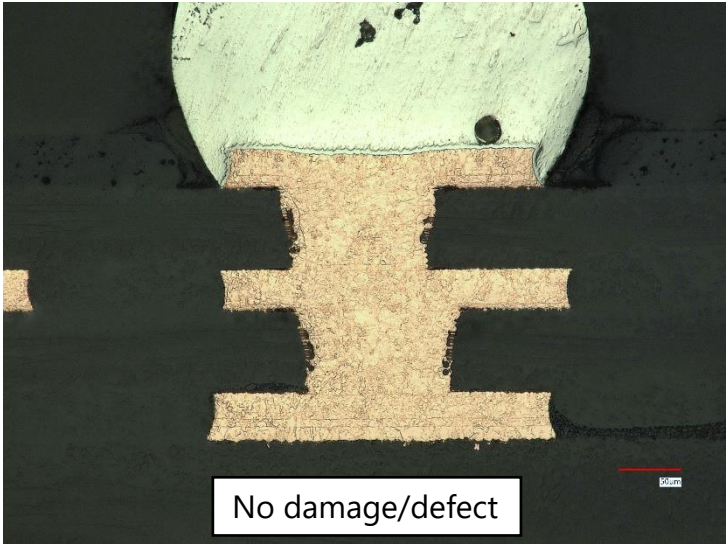
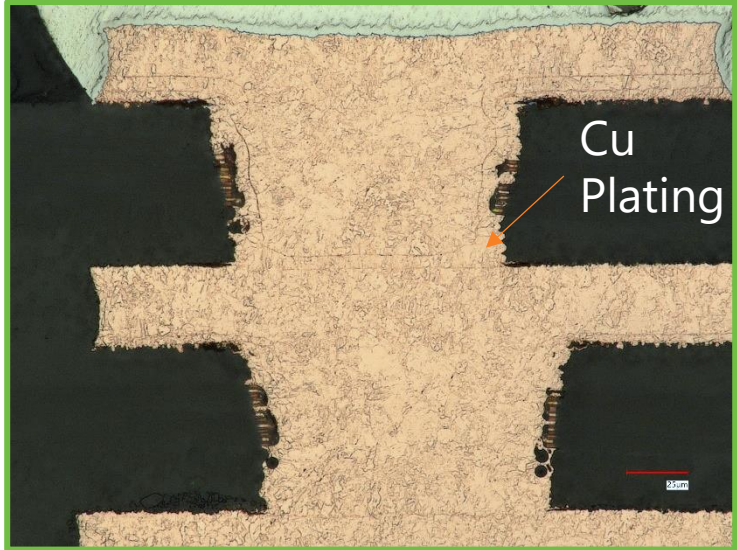
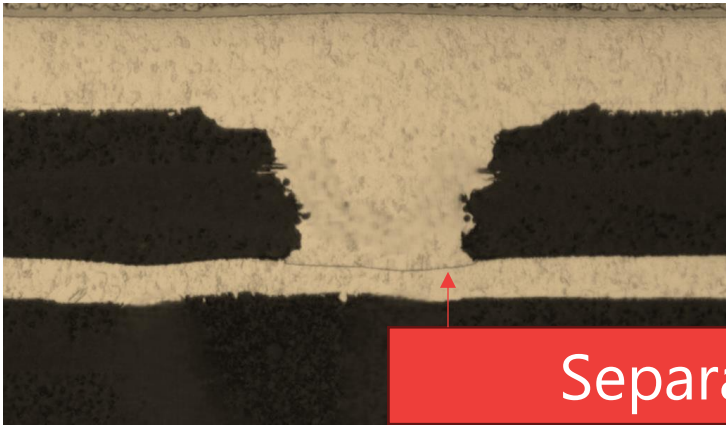
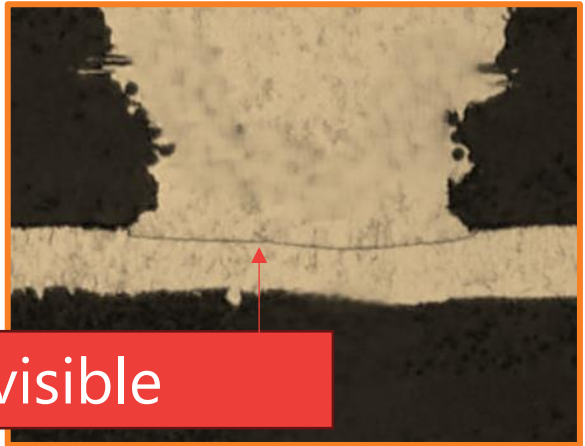
Separation visible

No crack, voids  
delamination or any  
structural  
irregularities.

Crack visible – no oxidation/contamination/defect detected with SEM/EDS.

High concentration of oxide present at the crack surface. No Ni or Pd layer typical from ELESS deposition were detected.

- **Root Cause Correlation**
  - Delamination at the interface between the copper plating in the via and the target copper pad led to electrical discontinuities and/or intermittent connections in the circuit.
- **Recommendations**
  - Process variables such as plating process parameters, including current density, bath chemistry, and agitation needed review followed by implementing reliability tests like IST (Interconnect Stress Testing) or highly accelerated life testing (HALT).

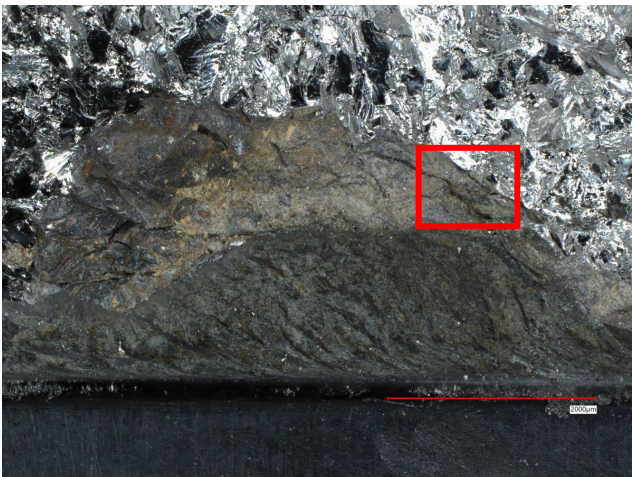
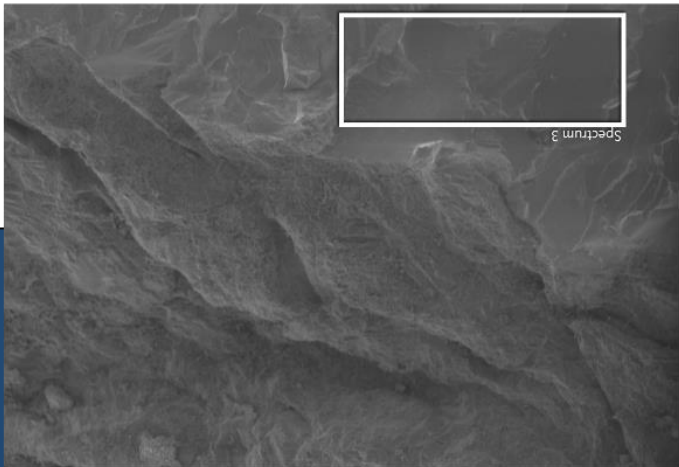
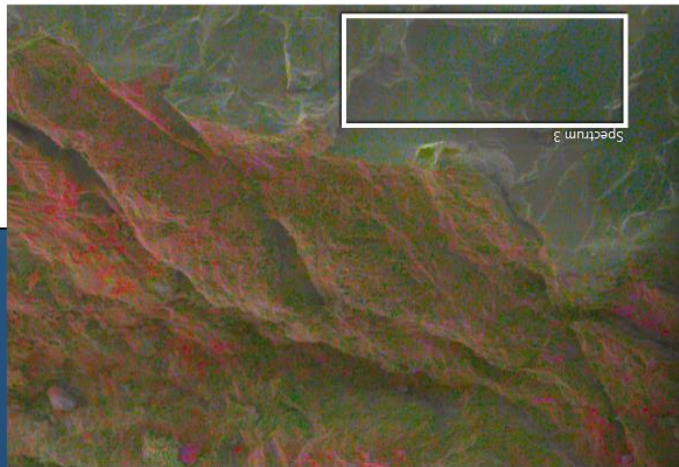
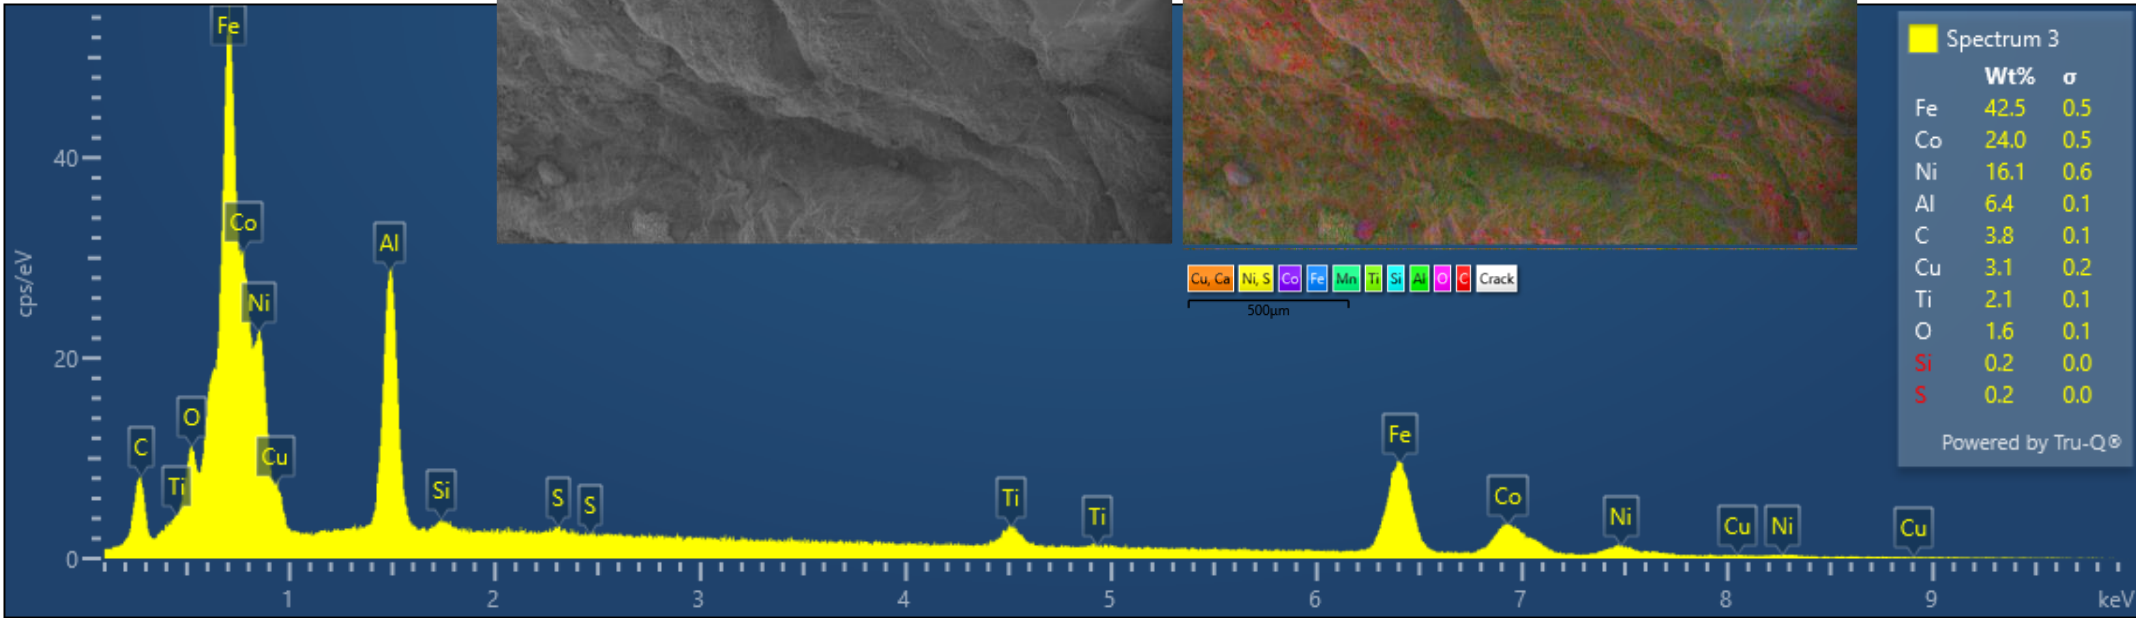
- SEM/EDS data was collected at the cryo-fracture surface to serve as a control to the area with suspected corrosion product

- SEM/EDS data were taken in the area covered in suspected corrosion product
- **O** concentration is higher than the cryo-fracture control surface, 29.2% compared to 1.6%.
- **Ca, Na, K, and Cl** were found on the surface and are indicative of the presence of corrosive species
  - The presence of these elements and elevated oxygen levels corroborates the hypothesis that the cracking observed near the edges of the sample is likely stress corrosion cracking

- **Root Cause Correlation**
  - Material composition is slightly off specs and could be related to composition drift, segregation.
  - Transgranular and intergranular cracking observed near surface and in the bulk of the magnet
  - Analysis suggests creep and stress corrosion cracking
  - Component failure due to material degradation, thermal cycling, and corrosion
- **Recommendations**
  - Manufacturing: Use tougher magnet material or protective coating to reduce brittleness (SmCo, NdFeB, Alnico 8/9 – need to understand environment needs to support decision
  - Improve mounting design (mechanical support / adhesive bonding to minimize vibration-induced stress)
  - Add vibration/thermal cycling qualification testing for future designs
  - Include predictive maintenance checks (flux density + vibration monitoring)

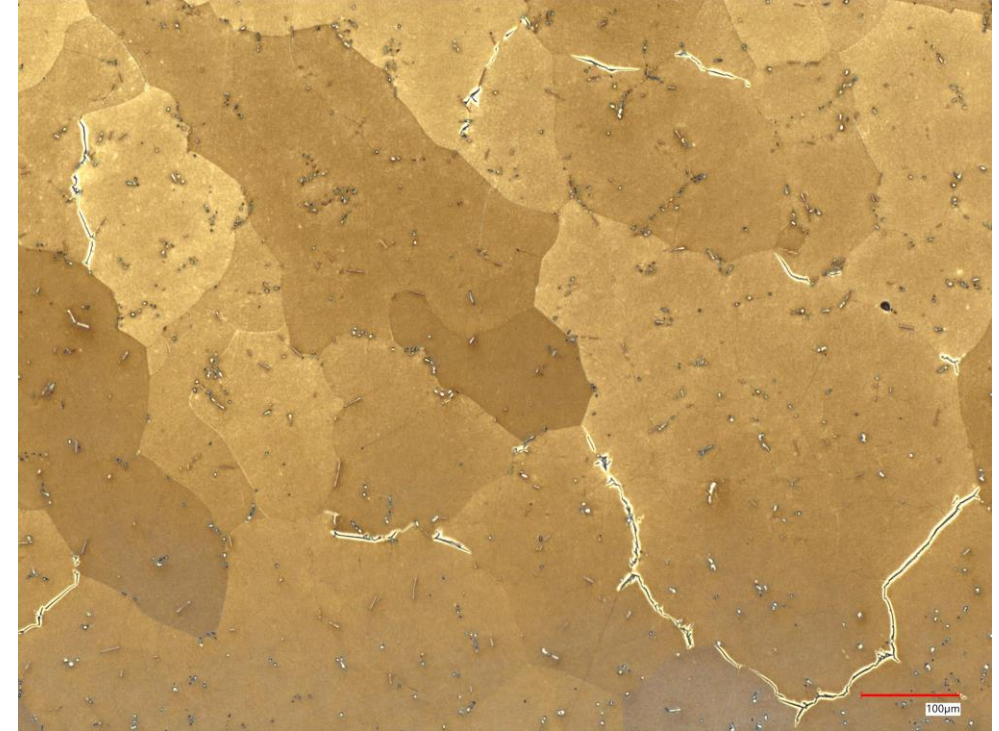
Hidden cracks in the magnet grew silently causing debris to build up in the housing that eventually brought the generator down — our analysis revealed the true failure path.

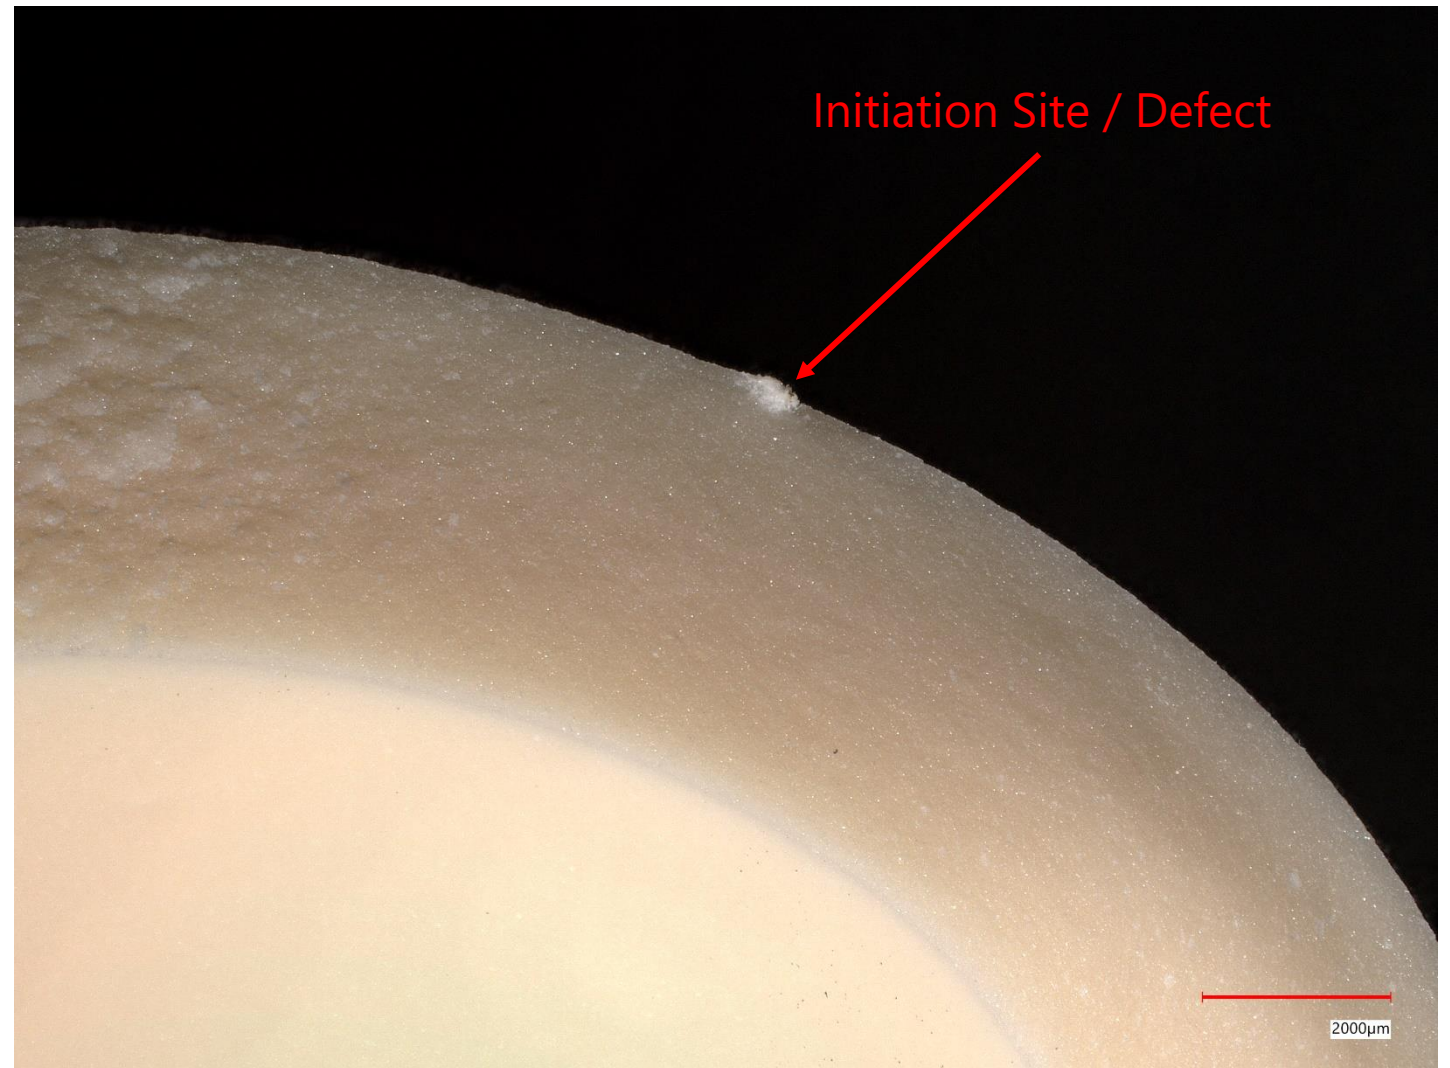
Optical image of the region of fracture initiation in different lightings to highlight hackle marks indicative of the direction of propagation. The red arrows show the direction of propagation starting from the defect.

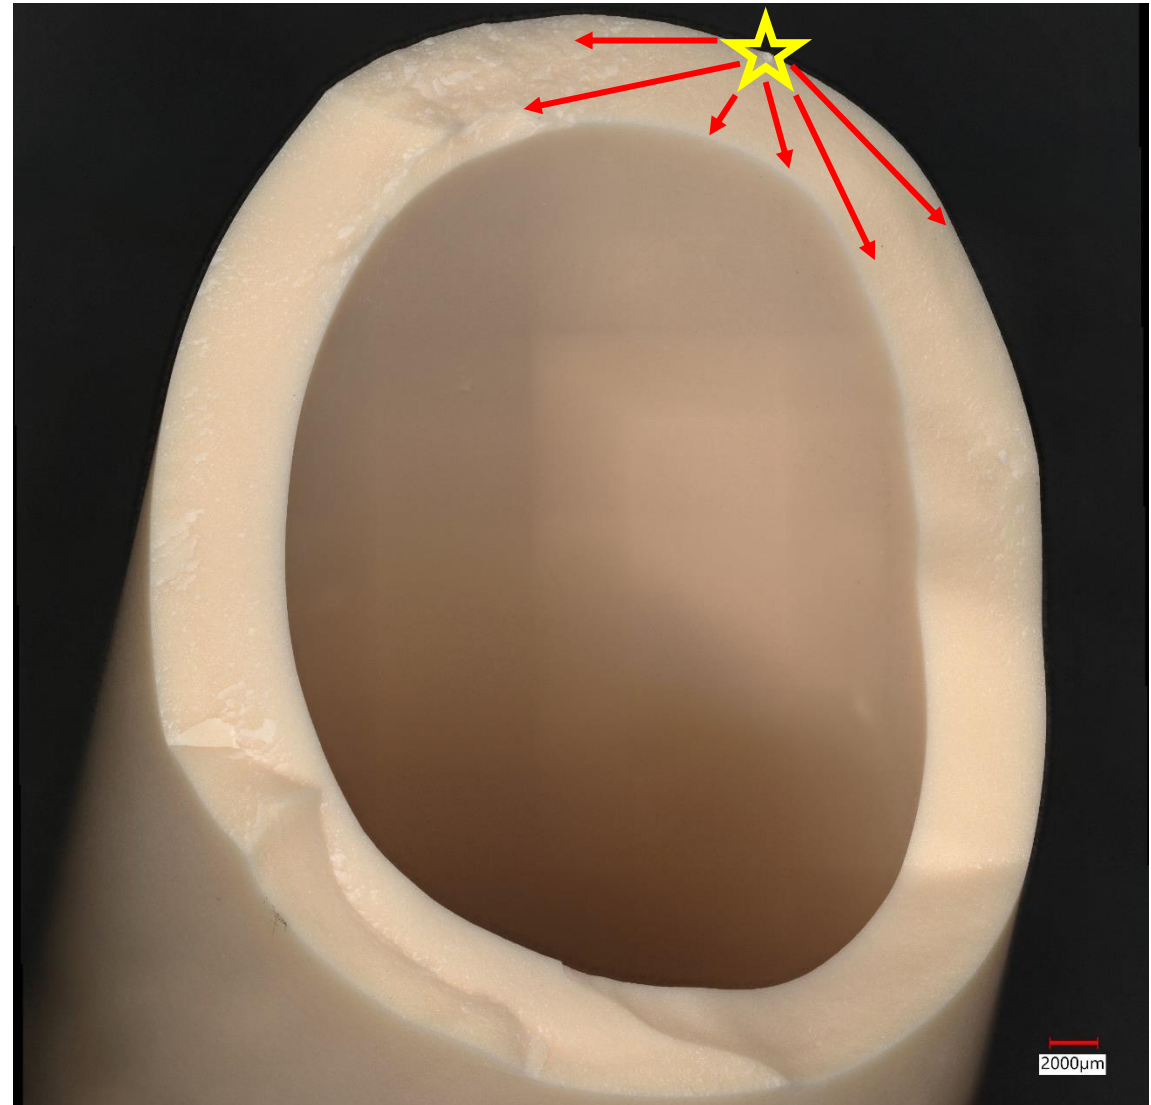
The fracture appears to have originated on the outer surface of the furnace tube where a cavity or pore was observed. The yellow stars indicate where the fracture initiated. The crack propagated outwards from the origin until the tube fractured. Based on the smooth morphology of the fracture surface, it is likely that the fracture took place in an instant.

- **Root Cause Correlation**
  - Localized stress concentration from pore formation during manufacturing.
  - Brittle failure due to the localized stress, from porosity and heating of the tube, exceeding the stress required for fracture to initiate
- **Recommendations**
  - Manufacturing: Pores such as the one observed on the failed sample are commonly associated with incomplete sintering or pore forming agents. Investigation into the sintering profile and presence of pore forming agents could help to negate pore formation.
  - Quality Check: Samples should be visually inspected post-manufacturing to look for pores and inclusions that may result in failure when furnace tubes are exposed to in service conditions.
